THE PORTLAND BUILDING

RECONSTRUCTION PROJECT

DESIGN ADVICE REQUEST

December 19, 2016

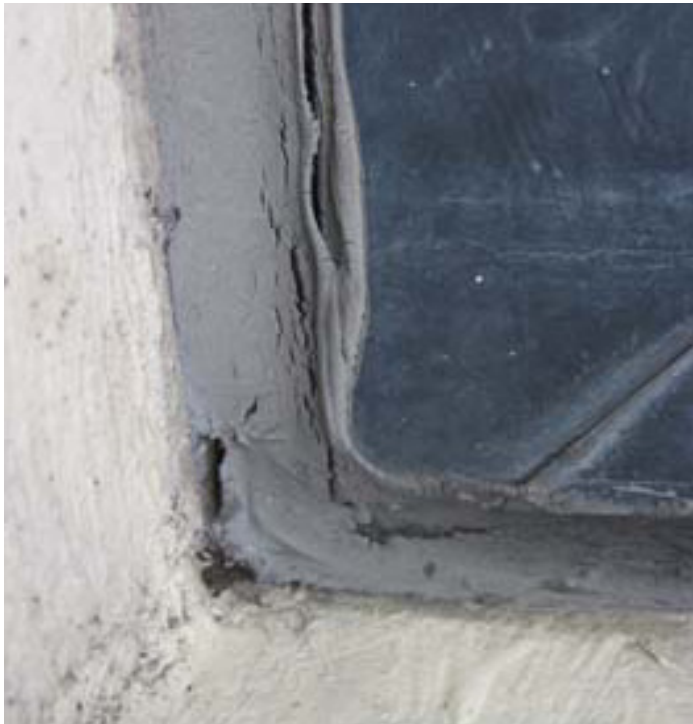
Failed sealant at punched window perimeter joint

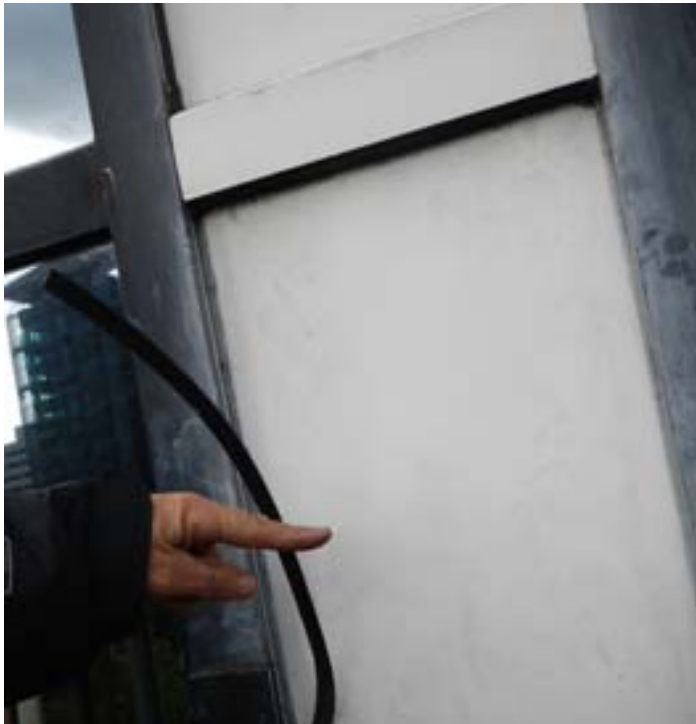
Failed gaskets at curtainwall system

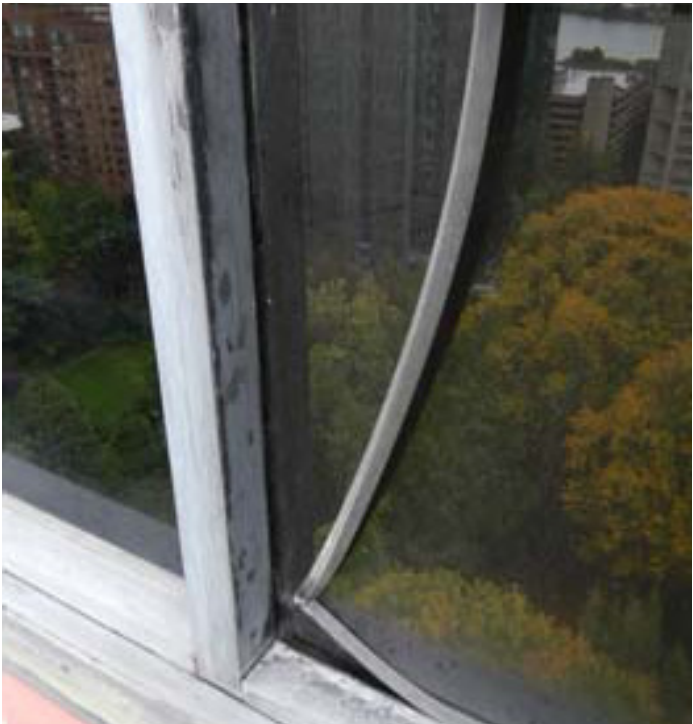
Failed gaskets and oxidized finish at ribbon window frames

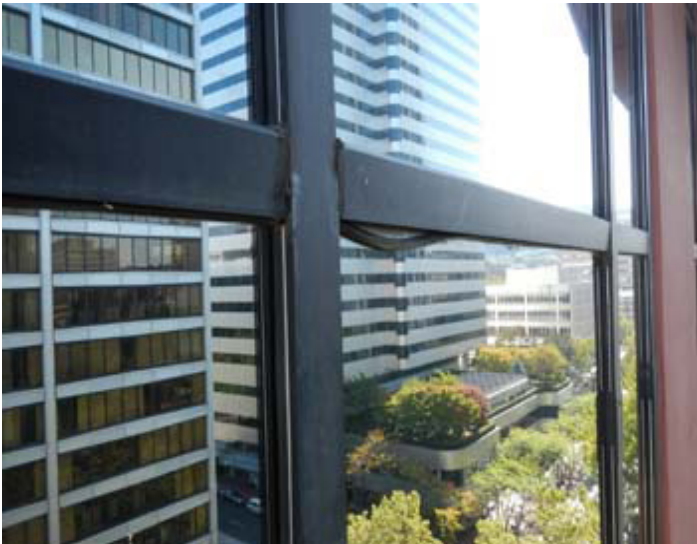
Failed gasket and displaced pressure plate/cap at curtainwall

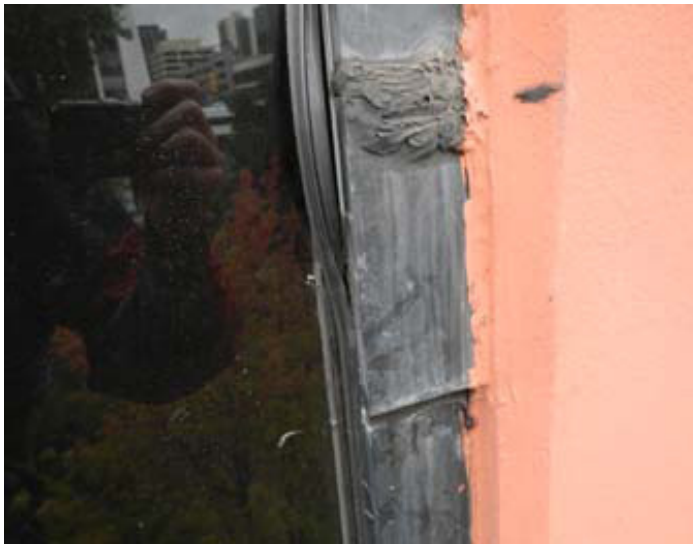
Failed movement splice connection at curtainwall jamb

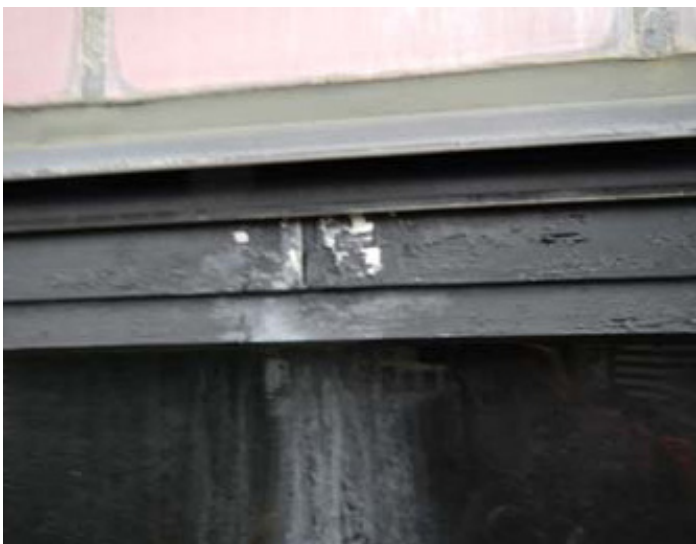
Failed metal finish at ribbon window head

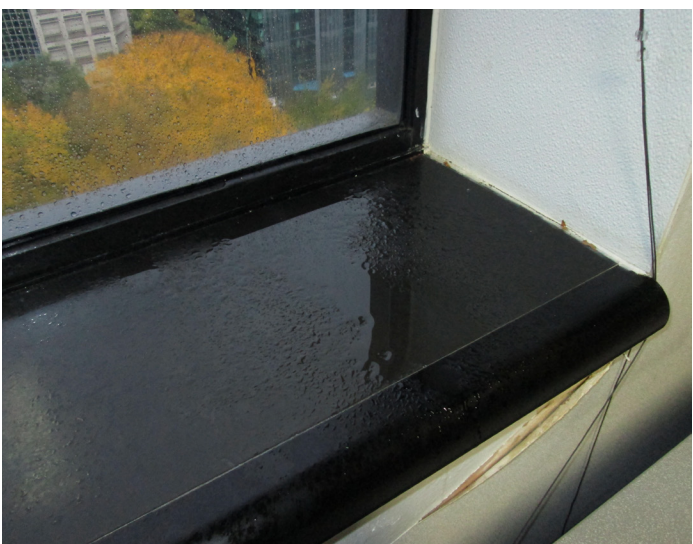
Water infiltration at 14th floor ribbon window

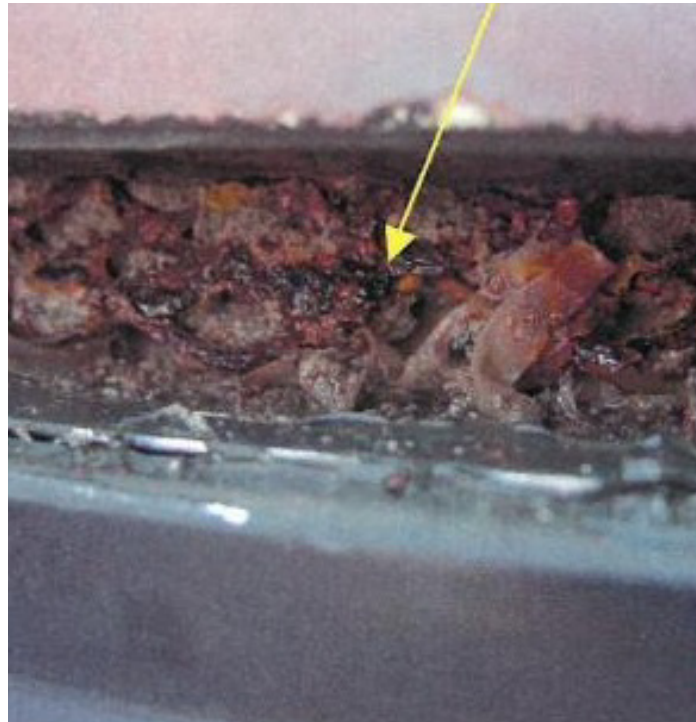
Rusting metal lath expanding behind tile system

- Failed ceramic tile systems - continuing efflorescence at grout that obscures the intended black color, cracked/broken tiles, improper past re-pointing efforts, deteriorated/cracked grout, areas of rusted metal lath forcing tile out of plane, failed control joints, and biological growth in grout joints.

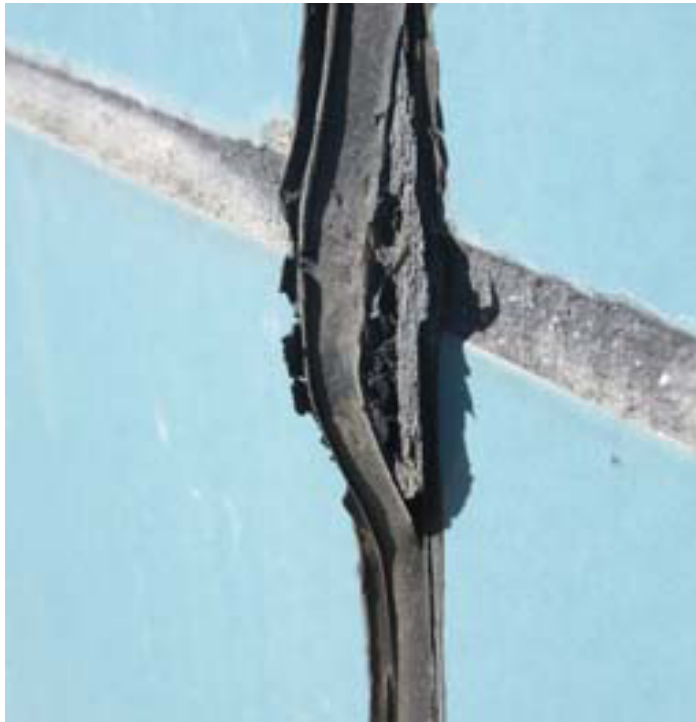
Failed sealant at tile system control joint

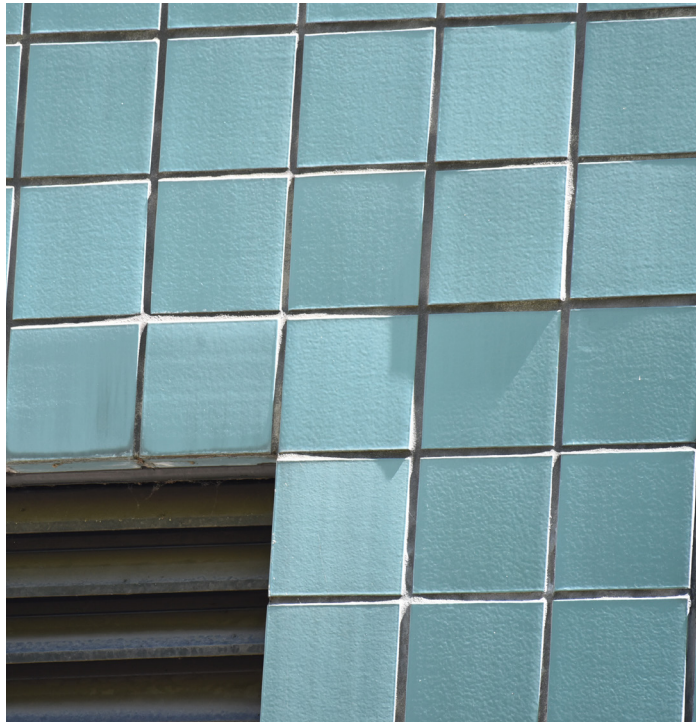
Out of plane tiles potentially delaminated from wall

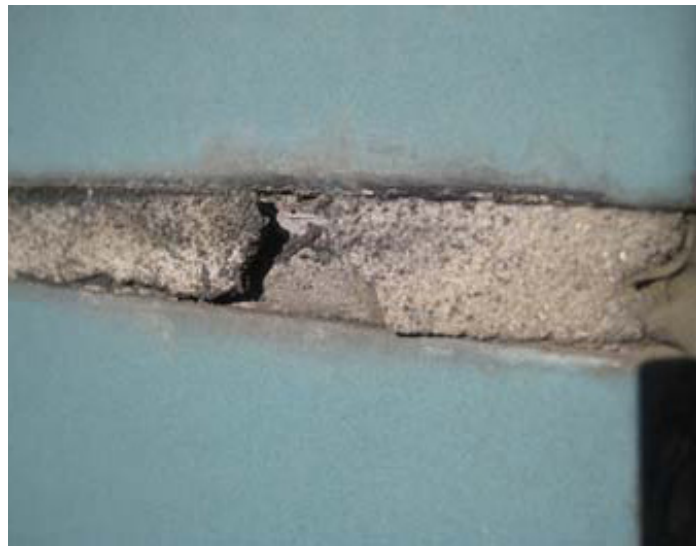
Failed grout in joint/efflorescence

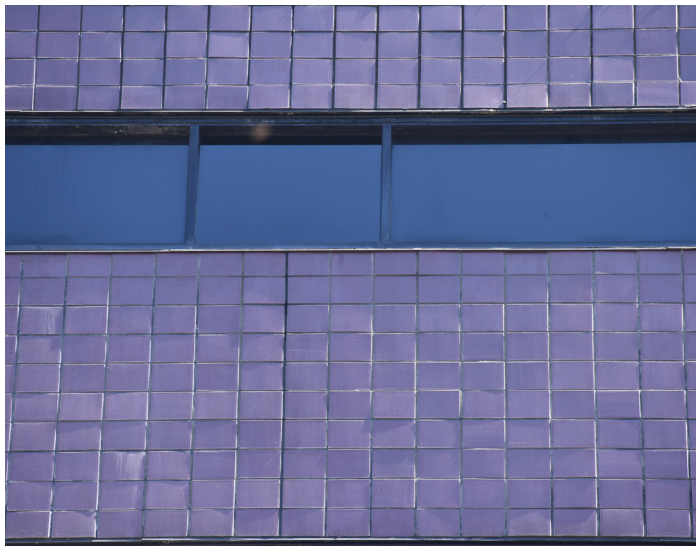
Out of plane tiles potentially delaminated from wall

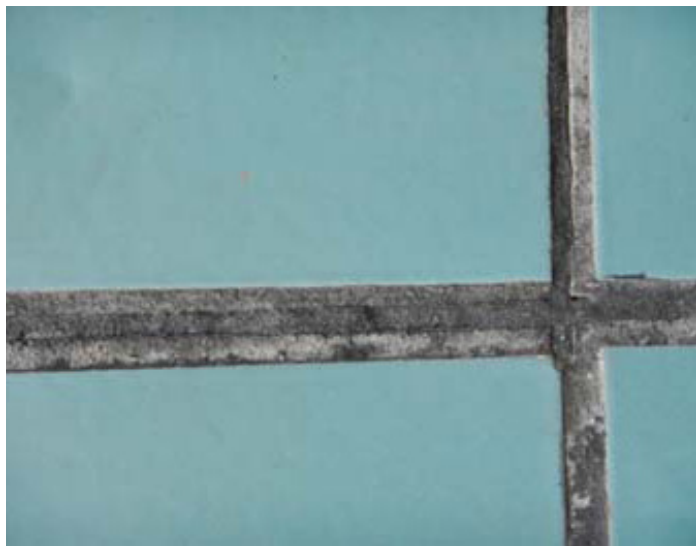
Seams in improperly repointed grout

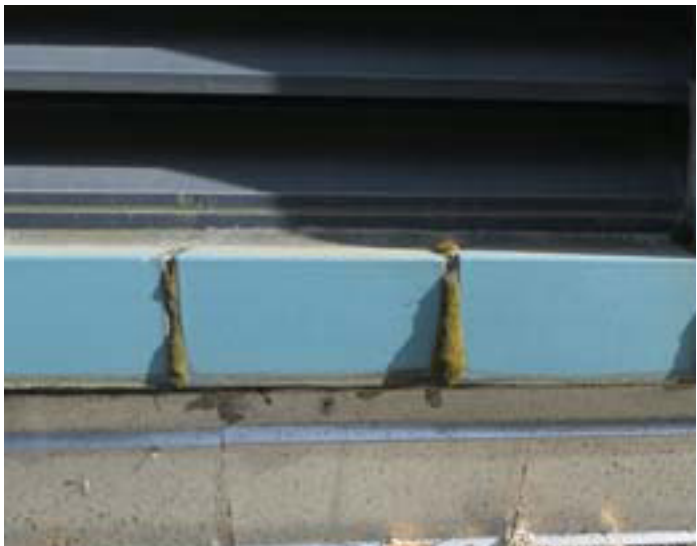
Biological growth at grout in joints

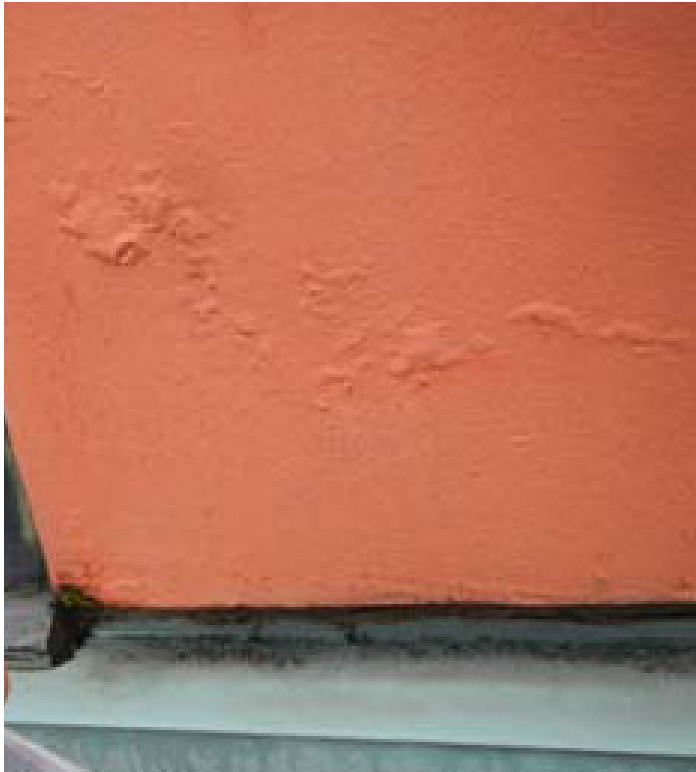
- Failed elastomeric coating - In many areas, the elastomeric paint (which is the concrete's primary defense from water) has been compromised, allowing water to become trapped behind the paint.
- Spalling concrete - Areas where moisture has infiltrated the coating has forced some patches of the concrete to spall.
- Condensation - The concrete wall has little resistance to exterior thermal conditions. The interior side of the mass wall frequently develops condensation which is then trapped within the furring wall. This creates an ideal environment for microbial and fungal growth within the furring cavity.

Bubbling at elastomeric paint

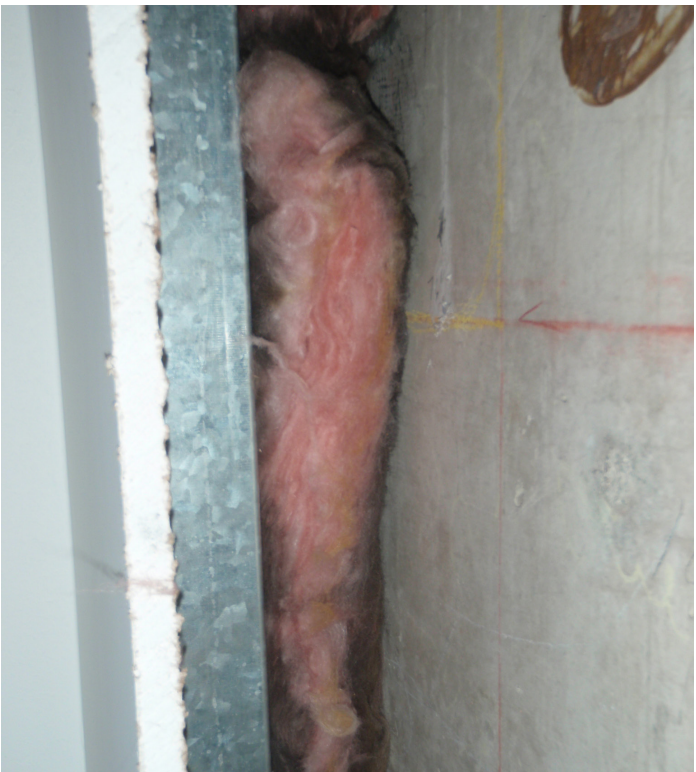
Insulation discolored by moisture from air or water infiltration

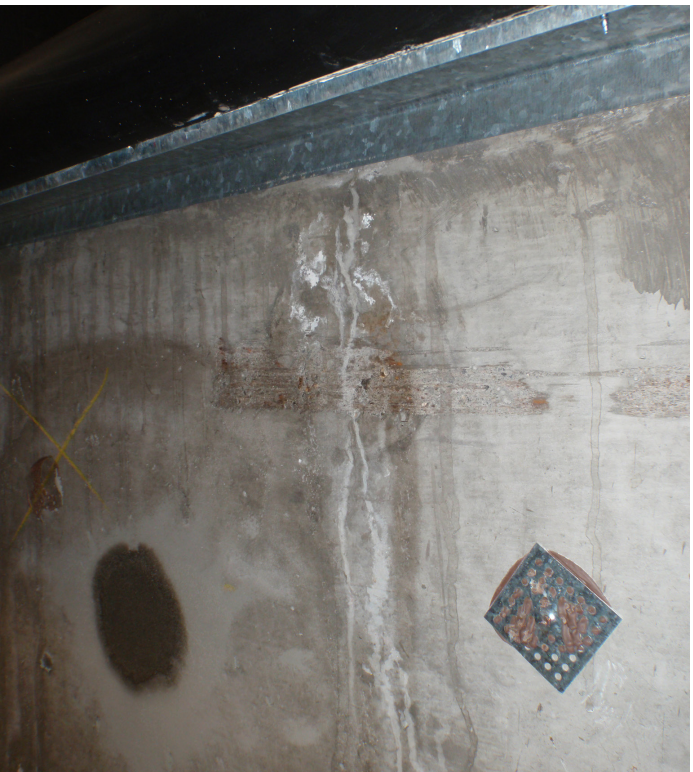
Water staining on interior side of concrete wall

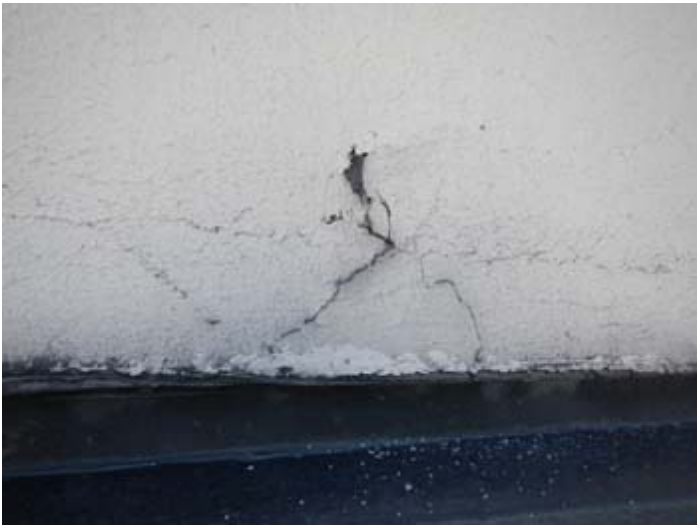
Cracking at exterior side of concrete wall

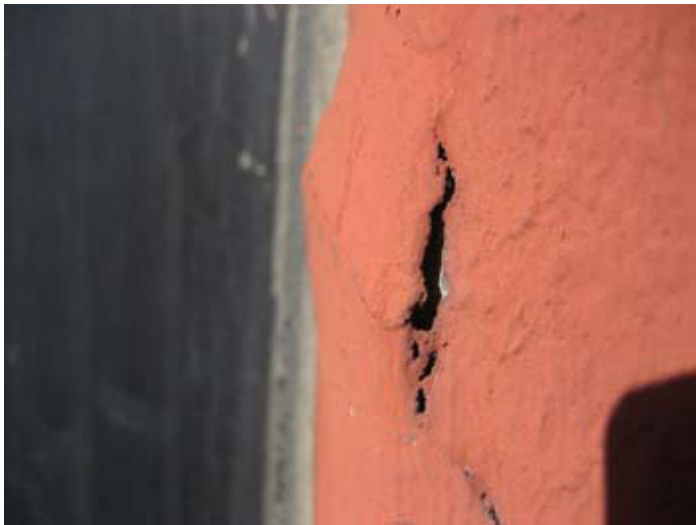
Failed elastomeric paint and loose concrete edge

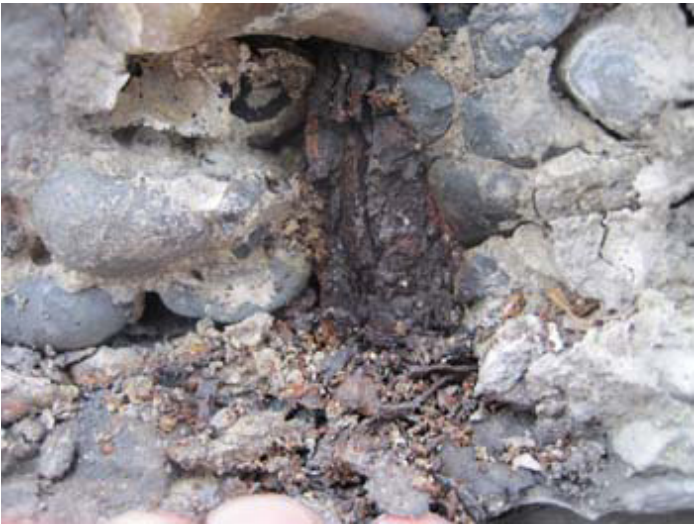
Spall and rusted reinforcing at exterior concrete wall

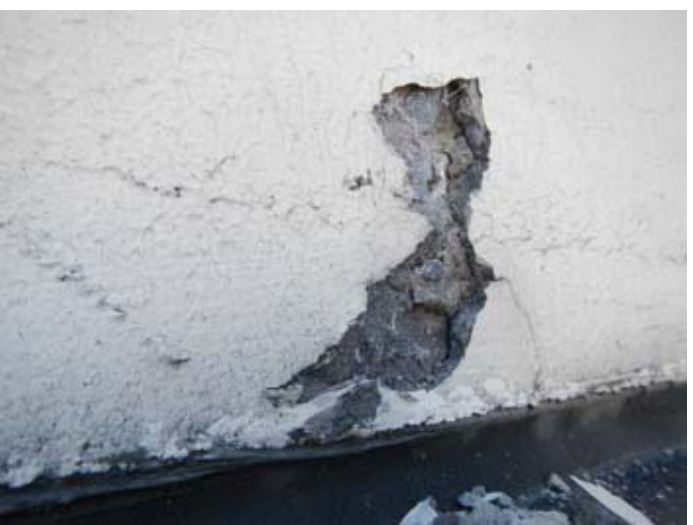
Spall at exterior side of concrete wall

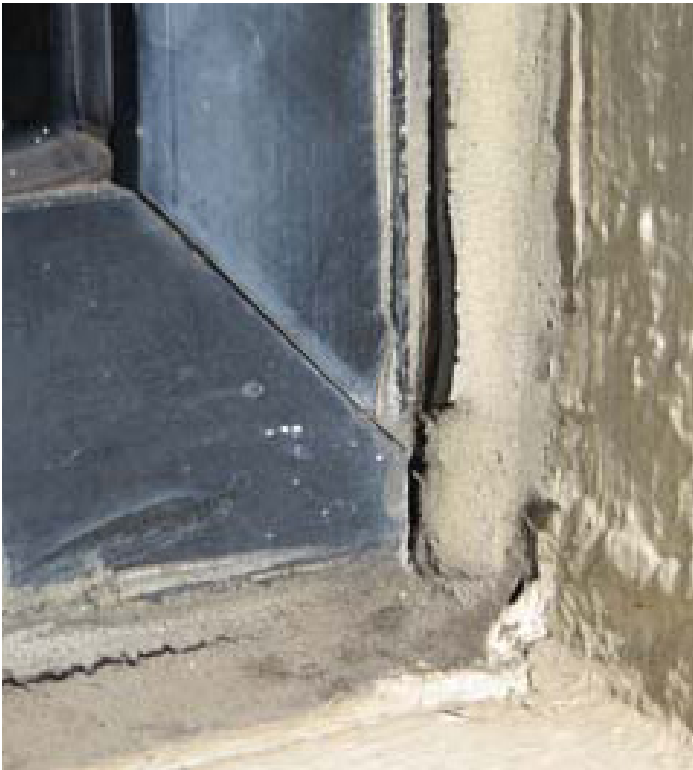
- Failed sealant joints - Existing sealant materials are experiencing both adhesive and cohesive failures.
- Improper sealant applications - In many instances, joint repair/maintenance was done by applying new sealant over existing sealant rather than removing it and doing proper surface preparation.
- Sealants applied to weeps - In many locations within the curtainwall assemblies and in some tile transitions, the few system weep holes that are existing have been covered with sealant, exacerbating the water issues.

Adhesive and cohesive sealant failure

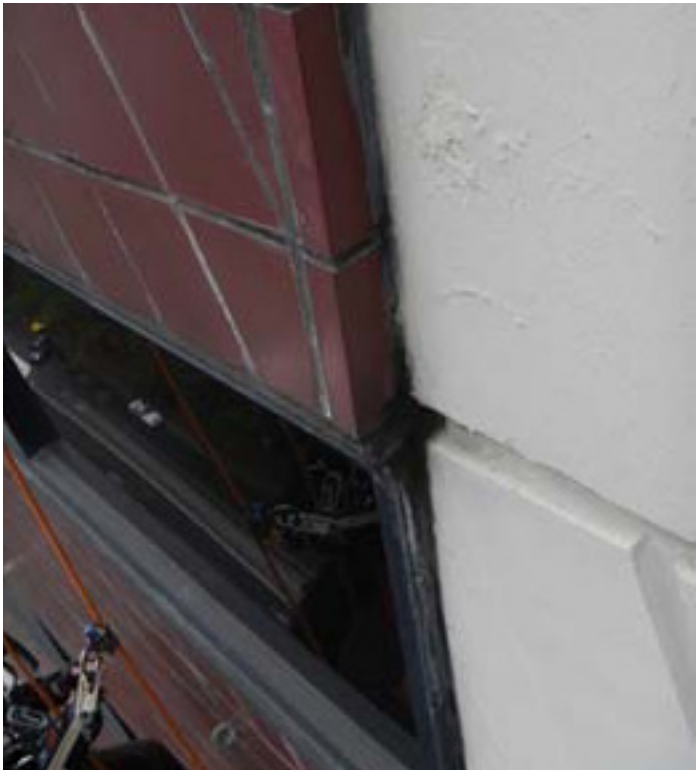
Weather tightness of transition dependent on sealant

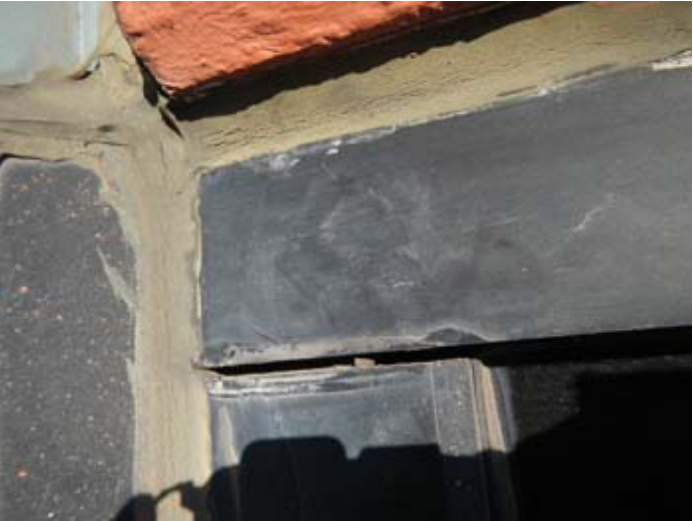
Complex material transition joints dependent on sealant

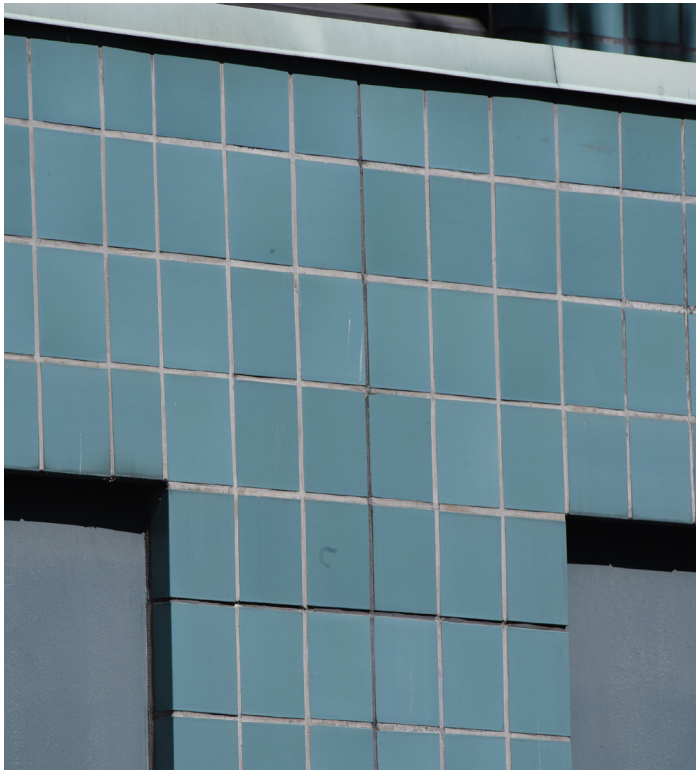
Tiles cut to different widths to maintain alignment

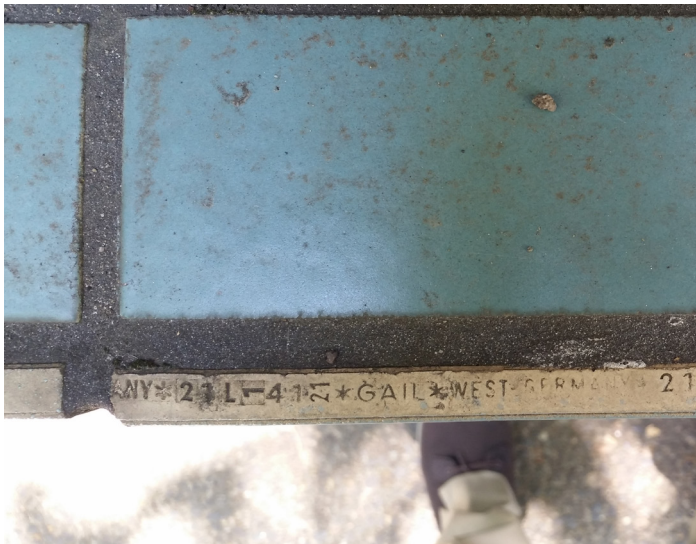
Field tiles modified for a corner condition

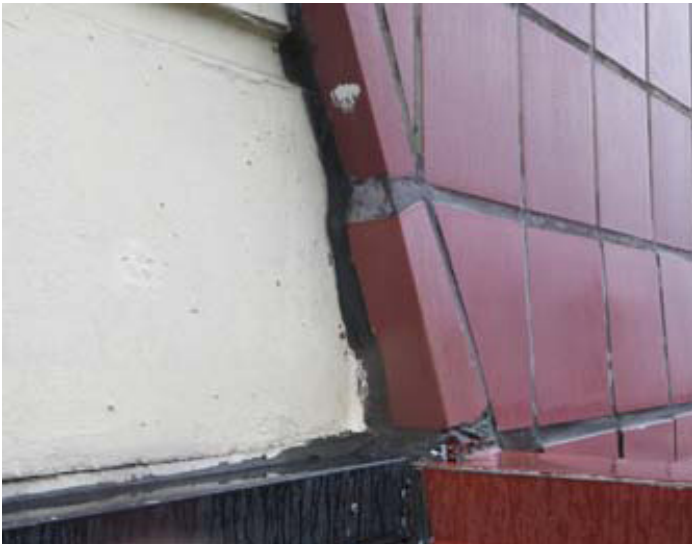
Modified tiles at keystone with irregular joints/alignment
