CONCRETE AND MODERNISM: TECHNOLOGY AND CONSERVATION

Preservation Technology Dossier 14 - 2018

INTERNATIONAL SPECIALIST COMMITTEE/TECHNOLOGY DOSSIER 14

*Proceedings of the Docomomo International Specialist
Committee/Technology sessions during the 3rd annual
Docomomo US National Symposium.*

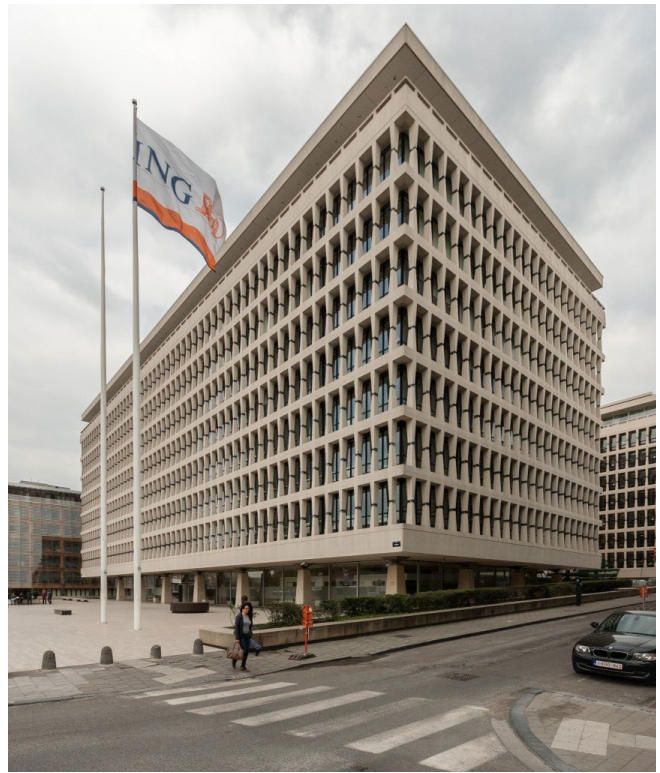
The Banque Lambert project designed by Gordon Bunshaft is exceptional in that it represents a significant project to the internationalization to American corporate architecture. It was like a number of the projects featured here, in demonstrating an innovative engineering feat. In this case the use of the stainless pin joints between panels at mid-span and the use of the exterior precast panels as load bearing elements as well as for their aesthetic value. The precast panels were produced in the Schokbeton plant in Kampen, The Netherlands.

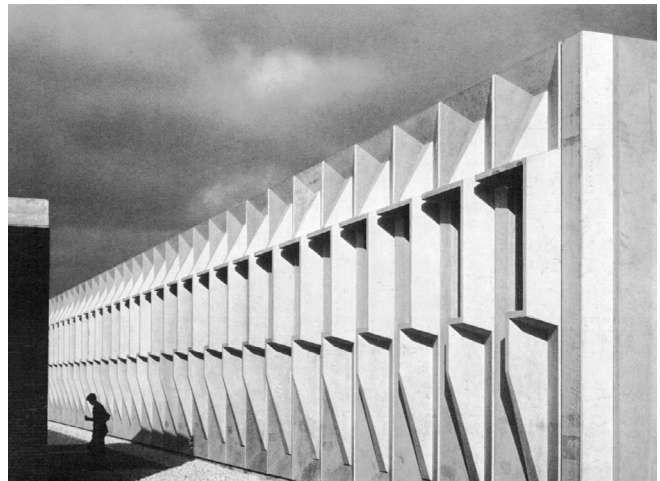
Concrete was extensively used by Marcel Breuer. A significant design interest of his was the exploration of the use of shadow and light in architectural expression. The Torrington Plant in Nivelles, Belgium takes a simple tilt up construction technique and extrudes an exceptional presentation of Breuer's design intent. While simple in concept, the amount of relief and scale of the Torrington panels could only have been achieved by the Schokbeton process.

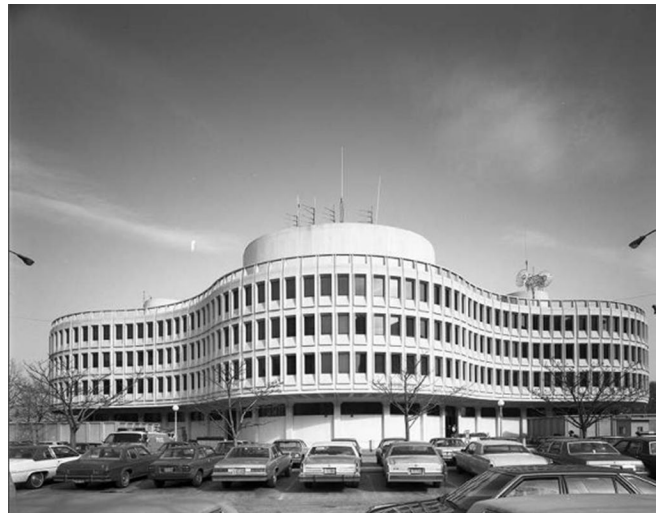
The structural core of the building was two cast-in-place cylinders (each contained the elevator and stair) that received pie shaped precast floor panels. The floor panels were multiple units post tensioned to 60 tons. The outboard most component of the floor assembly was a 12' section cantilevered beyond the outer radiused column and beam line. The outboard edge of the post tensioned cantilevered floor slab supported three story architectural and structural panels that carried two floors above. The exterior panels provided enclosure and were detailed to accommodate windows, piping, power and under-window heating units. This project was accomplished pre-computer. The degree of detail and exceptional execution represented the state of the art at that time.

(Photo: View from the south showing the parking lot and the convex south walls of the Roundhouse. Peter Olson, Police Headquarters. Olson Collection. The Athenaeum of Philadelphia.)

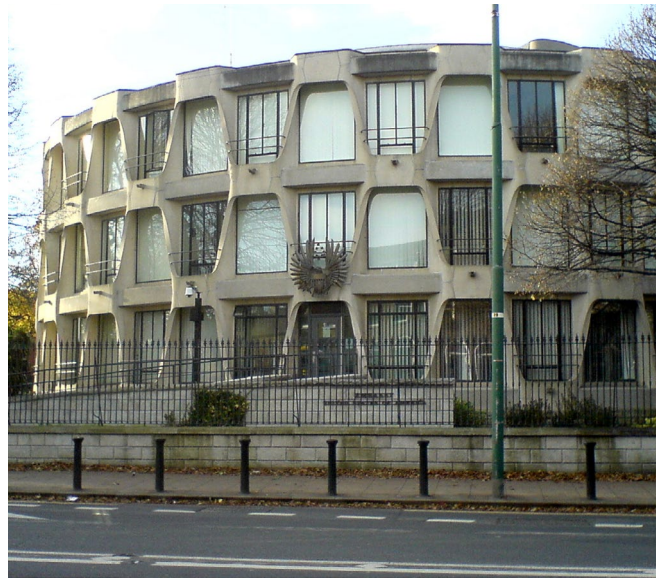
The US Embassy shares geometry and its corresponding efficiencies with the Police Headquarters. It also shares being virtually an all precast building. What is exceptional about this building and its use of precast concrete is the sculptural quality of the precast elements, again, produced in a pre-computer age. The building's exterior enclosure was efficiently constructed from three mold shapes. The basic sculptural element of the design served as a structural column, a portion of a spandrel panel and a portion of a balcony railing. In addition to the integration of design and technology, this project and specifically the primary sculptural component of the design was a dramatic example of the linkage between technology and craft at that time. If it had not been for exceptionally skilled craftsmen, this project could not have been done. Without the shock table technology, this project could not have been realized.

The Dublin Embassy was designed in the USA by John Johansen, an American architect, cast by Schokbeton in the Kampen, The Netherlands plant, and shipped from Kampen to Dublin over the North Sea. For any construction project this is a daring set of circumstances. Any mistake in design, coordination and/or delivery would have a catastrophic impact on the project. In the design and production phases of the project Johansen made visits to the Kampen Schokbeton plant to inspect prototypes and work with the mold builders to produce this exceptional project.

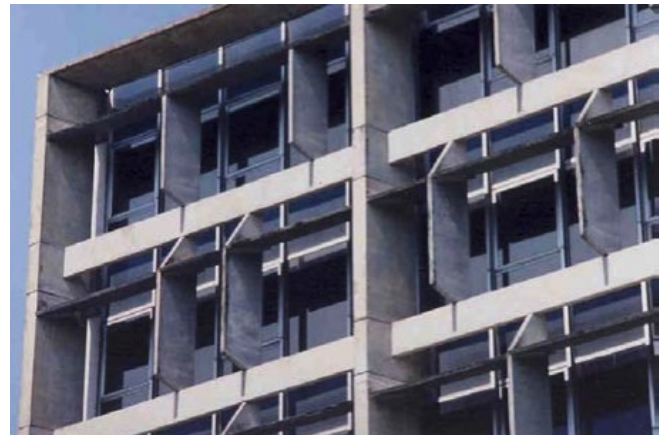
The ensemble consists of four blocks with different heights housing different uses. Its main facades are protected by a "grid" of vertical and horizontal brises-soleil made of concrete (Fig. 2). According to Vital Pessoa de Melo, the building "was made in those principles of expressiveness of materials, the concrete expression". The architects proposed an independent concrete grid attached to the main block facade, thereby creating a facade with depth. The position, direction and inclination of the brises were defined in such way to protect the glass curtain wall more effectively during times of higher solar incidence. The fixing of the brises is made either by independent columns or by beams extending from the façade to support them.

FIGURE 2: CELPE Buildings, Detail of the front façade
detail of CELPE with vertical and horizontal brises.
Photo: Ana Holanda (2011).

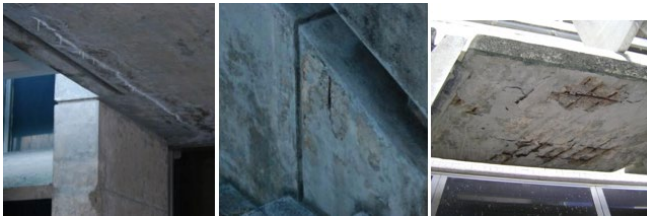
- Efflorescence stains and cracks, which occur mainly in the main building entrance slab (Fig. 3). Such damages, according to a report provided by the company responsible for the intervention, were caused by a leak that occurred in the slab of the canopy
- Corrosion and detachment of the concrete cover (Fig.3)

FIGURE 3: CELPE building slab canopy damage (efflorescence), detachment of the concrete, brise corroded with concrete detachment. *Photos: Barbara Aguiar (left, center) Source: CONCREPOXI, 2009 (right)*

The interventions performed included: 1) rehabilitation/ replacement and waterproofing of exposed concrete components of the façade (brises, pillars), and the stairs to the building (Fig.6); and 2) Rehabilitation and waterproofing of the building entrance slab.

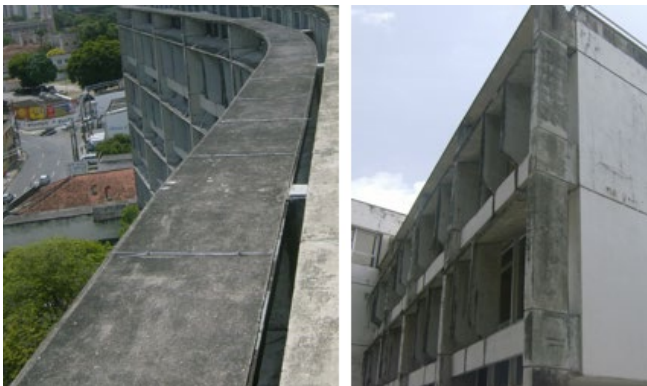
- Generalized stains on the surfaces of exposed concrete (Fig. 4). These spots were caused both by the acidic soot accumulated on the surfaces of exposed concrete, such as moisture.

FIGURE 4: CELPE building, Stains caused by acid soot and moisture, generalized spots. *Source: CONCREPOXI, 2009.*

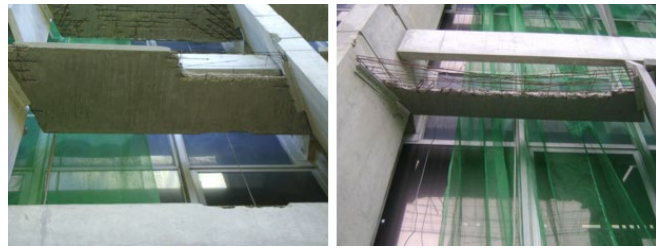
- High degree of deterioration of the horizontal and vertical brises of the façade (Fig. 5). Some of the brises had no prospect of recovery and their replacement was the only possible solution.

FIGURE 5: CELPE building, brises with high degrees of deterioration (to be replaced). *Source: CONCREPOXI, 2009.*

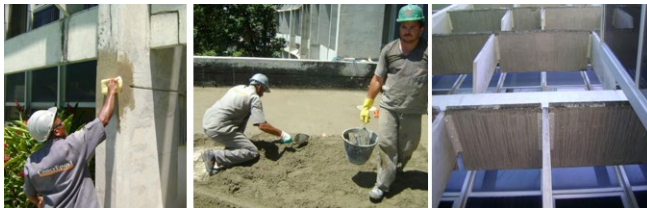
FIGURE 6: CELPE building, interventions performed: Recovery of pillars and louvers, slab of the main entrance .
Photos: Concrepoxi , 2009

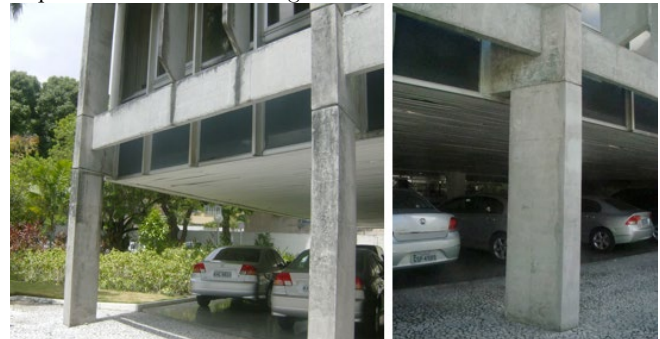
The current appearance of the surfaces recovered or the replaced brises hold some visual conflict with the original ones (Fig. 7). Thus, the recovery of these elements brought gains for the significance and integrity of the building, to the extent that it recuperate the ability of the concrete to transmit its values. Excepting for the material aspect, there were also gains for the authenticity, since the project managers were concerned to document every step of the whole intervention process, and to attempt to adapt the construction methods of today to existing materials, always considering the cultural importance of the building.

FIGURE 7: CELPE building, south facade in 2008 before the intervention. Pillar presenting moisture stains and corrosion and the same location in 2012. Pillar recovered in 2009 without major visual differences to the original structure. *Photo: Concrepoxi (2008) (left) Fernanda Herbster (2012) (right)*

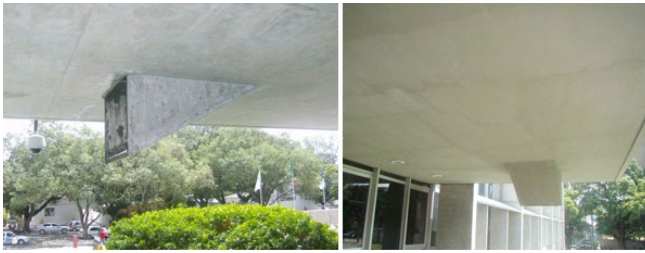
company used the same recovery technique of brises and pillars on the surfaces of the canopy, plus the treatment of cracks and new waterproofing. However, currently, the canopy is painted with ink on "concrete color", a fact that greatly decreases its rusticity and prevents the material values to be accessed in its entirety. The gargoyle used to drain water from the balcony was a very important point of rehabilitation, due to its high degree of deterioration (Fig.8-9).

FIGURE 8: CELPE Building, main entrance slab in 2008, before the intervention, with its original rusticity of exposed concrete, and in 2012, free from deteriorative processes, but coated with paint, including the gargoyle *Photo: Ana Holanda (2008) and Fernanda Herbster (2012).*

The recovery of the CELPE entrance canopy brought considerable gains for structural safety. It also brought aesthetic gains, since this slab, placed in an area with a large flow of people, is an important element in building the composition. Its recovery was crucial for the building to fully regain its values. The initial step was to remedy an infiltration that directly affected the canopy. Then, the

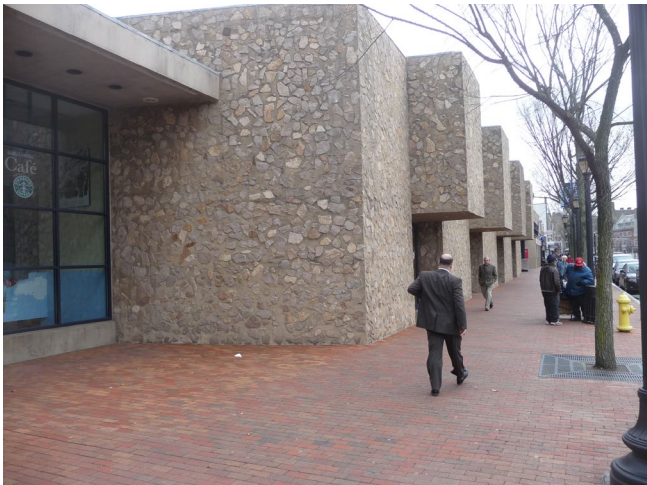
Morse and Stiles College at Yale University with distinctive rubble wall appearance.

The Samuel F. B. Morse and Ezra Stiles Colleges at Yale University (1958–1962) were among Eero Saarinen's last and most distinctive works. Instead of using stone or brick, which are more common on the university campus, Saarinen designed the colleges to be constructed with cast-in-place concrete exterior walls. The interior of the buildings has exposed concrete at columns, walls, and roof structure in the common areas.

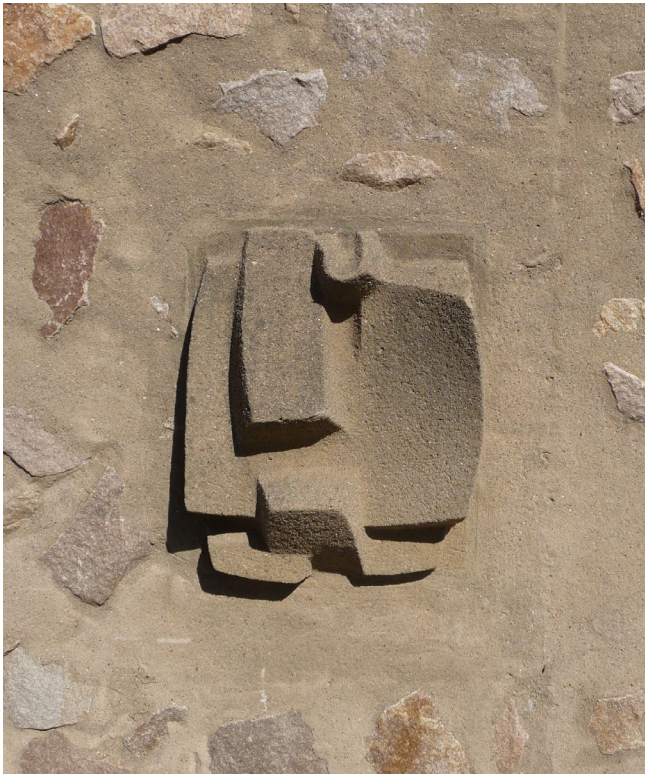
Concrete sculpture with smooth finish embedded into rubble concrete wall. The sculpture appears to have been mortared in place after construction of the rubble wall.

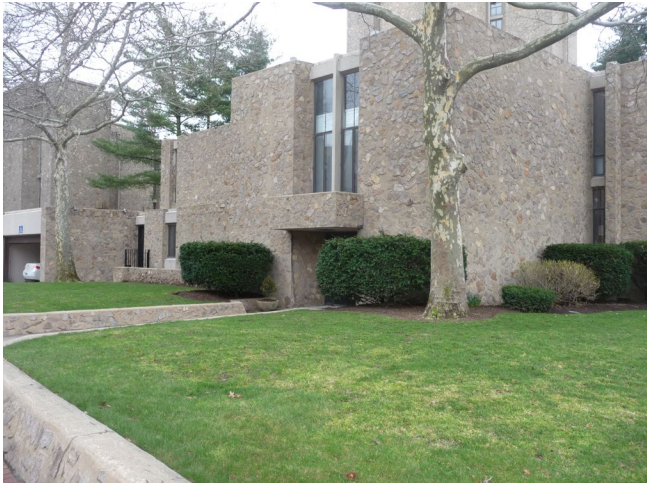
Overall view of rubble concrete walls with inset windows.

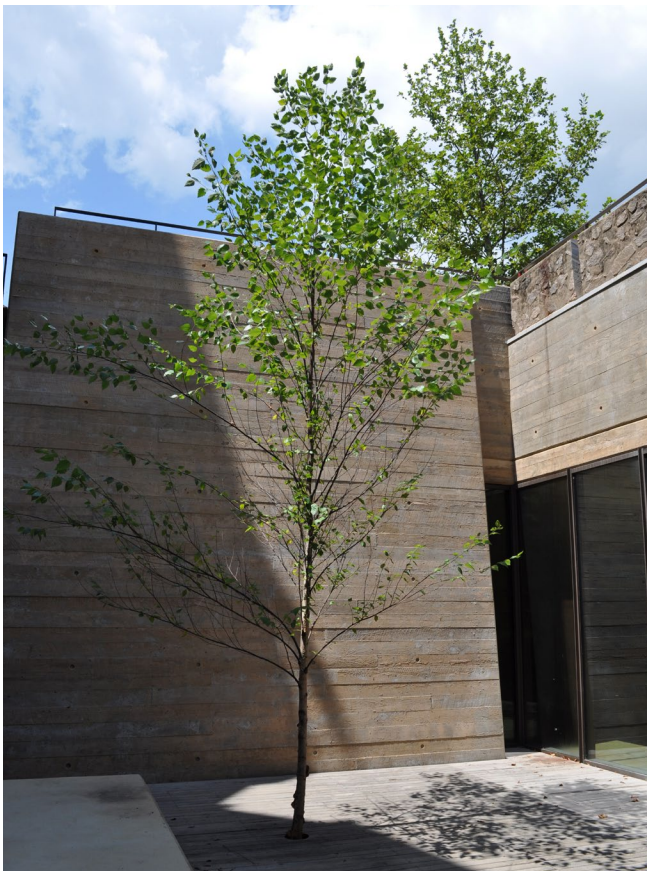
*Board formed concrete walls, slightly battered, that were part of the addition.
The original construction also included board form concrete walls.*

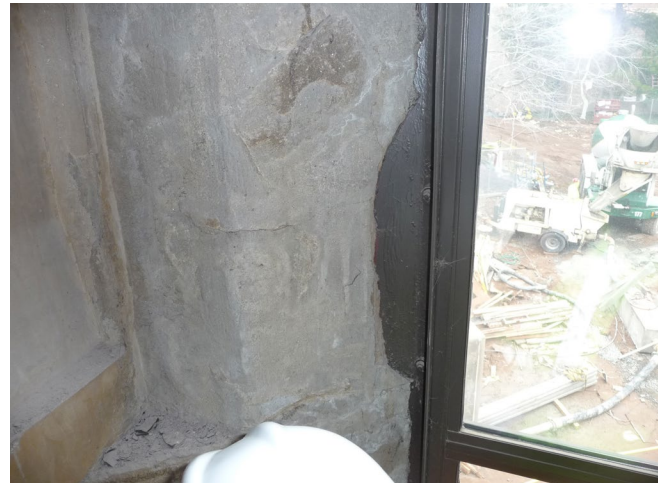
Rubble concrete wall with several different exposure levels of the rubble aggregate.

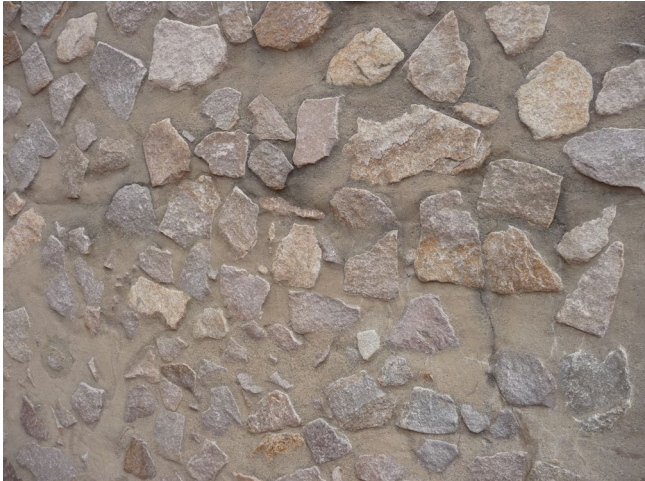
Close-up of rubble concrete, showing a crack on the right side and various levels of soiling.

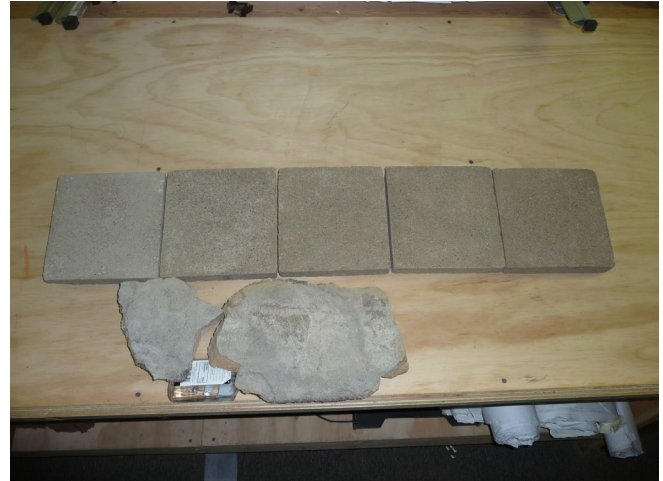
Various concrete mix sample designed to match the original architectural concrete, shown in the foreground. Note the different degrees of buff color in the mixes.

finish desired as part of the aesthetic envisioned by Saarinen. Each type of finished surface—large rubble aggregate, mortar parging, or board form finish—required samples, trials, and a high level of craftsmanship to properly match the original concrete. The first challenge was to identify the aggregates, sand, and cement used in the original concrete. A series of field mock-ups was conducted to refine the mix design and protocols for repair.

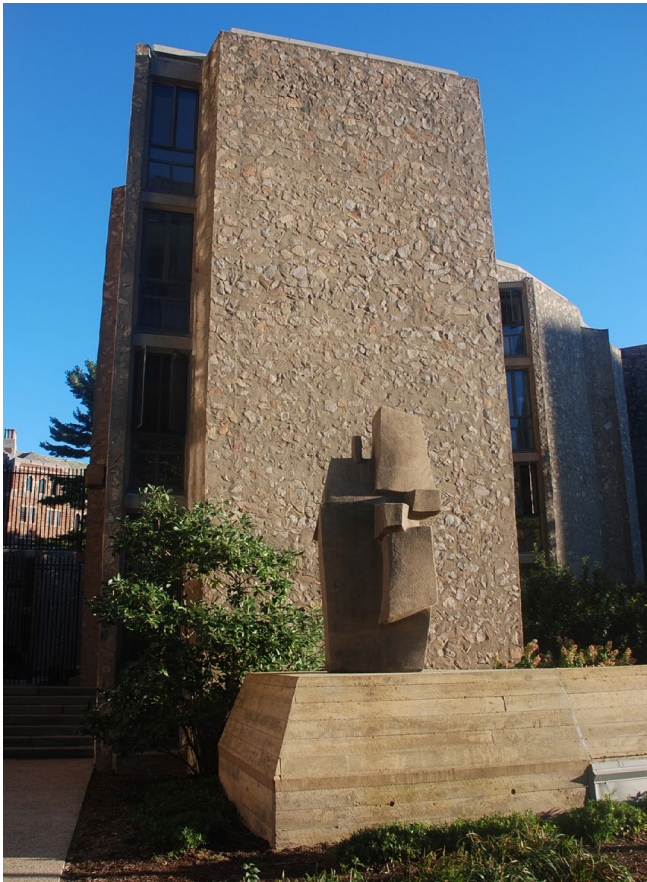
Rubble concrete wall with board form concrete in the foreground. Also note the decorative sculpture.
