Restoring Postwar Heritage

preservation technology
dossier 8
August 2008

Theodore H.M. Prudon FAIA
Kyle Normandin
Editors

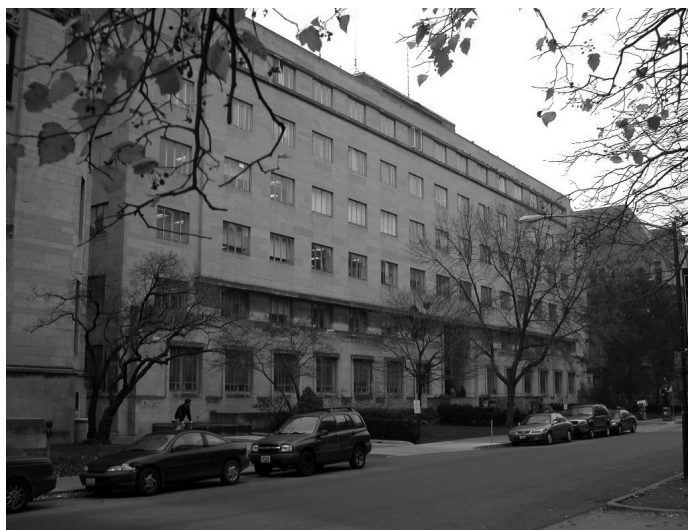
The administration building (Holabird and Root, 1946-1948) was the first building to break with the Collegiate Gothic style.

The unusual bi-fold windows at the Administration Building require frequent repairs. Parts are no longer available

At the Administration Building, the unusual bi-fold aluminum windows require frequent repair due to breakage of the operating mechanism. The windows are no longer manufactured and the university has considered various options ranging from replacing the windows with new operable units to retrofitting the existing units as fixed units, rather than continuing to repair and maintain the existing window units in operation. These options present different implications for maintaining the design intent and aesthetic of the building facades, and for meeting varying requirements of the university program, building users, and facilities staff.

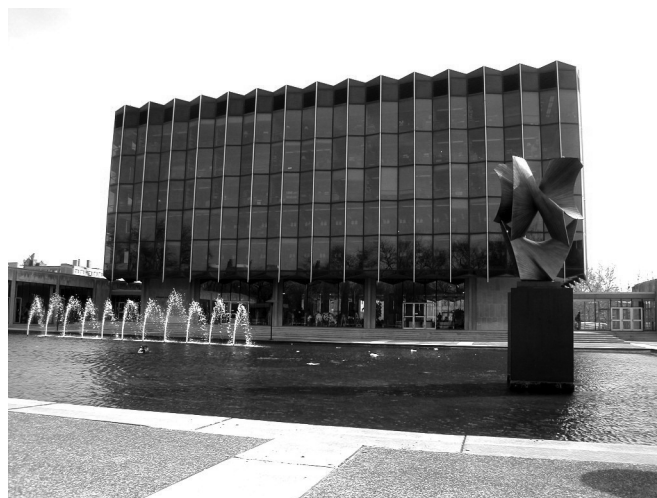
The Laird Bell Law Quadrangle (1959) designed by Eero Saarinen.

Thin stone cladding is present on the exterior of many of the buildings, with specific problems observed at the Laird Bell Law Quadrangle and the Laboratory for Astrophysics and Space Research. The spalls and displaced panels on the seminar wing of the law school and similar distress

The thin stone panels on the Laird Bell Law Quadrangle are deteriorated due to corrosion of the steel anchors.

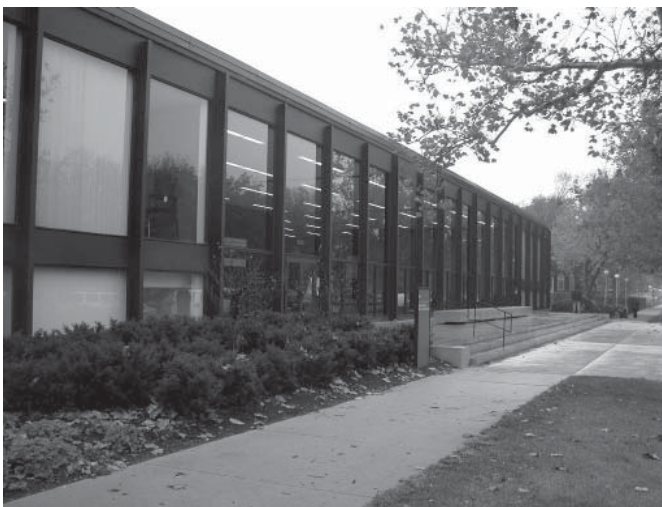
The School of Social Service Administration (Ludwif Mies van der Rohe, 1965) has experienced glass breakage from corrosion of steel elements.

The School of Social Service Administration has experienced glass breakage from corrosion of adjacent steel elements, which is related to condensation on the interior and water infiltration through open joints in the framing and glazing. The use of glass units in steel frames and the associated problem of glass breakage from corrosion of adjacent metal is not unique to this design or to modern buildings of similar design and materials. However, the problem is complicated here because of the large size and extent of the glazing units, and their importance to the design intent and original aesthetic. Any changes to the materials or details of the window frames glazing would affect the appearance of the facades. The curtain wall glazing on the Law Quadrangle Library has been replaced previously with insulating glazing units to provide improved energy efficiency. The similarly extensive curtain wall at the School of Social Service Administration retains its original single glazing, and alteration of these units would likely not be acceptable.

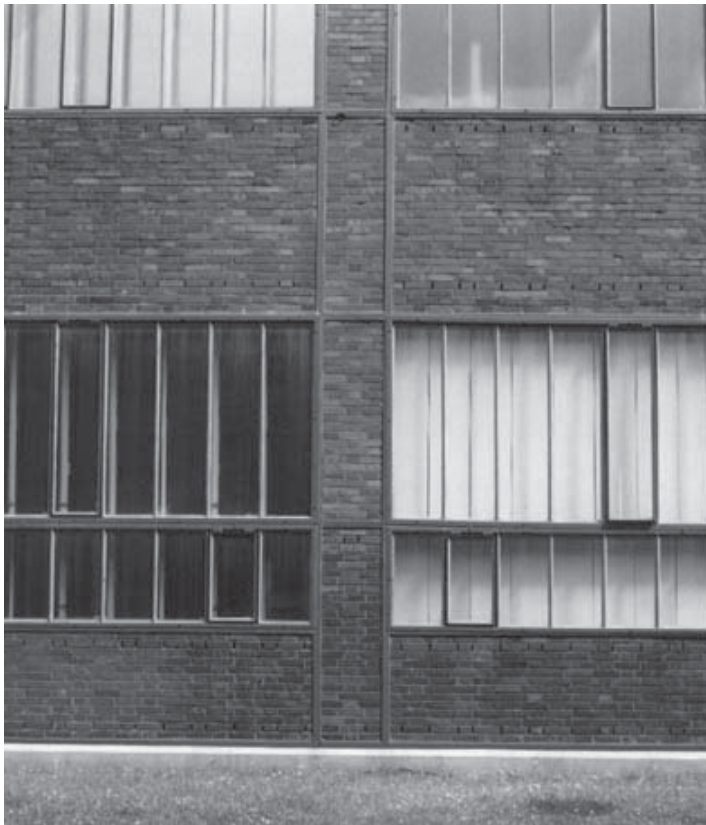
Detail of renovated curtain wall.

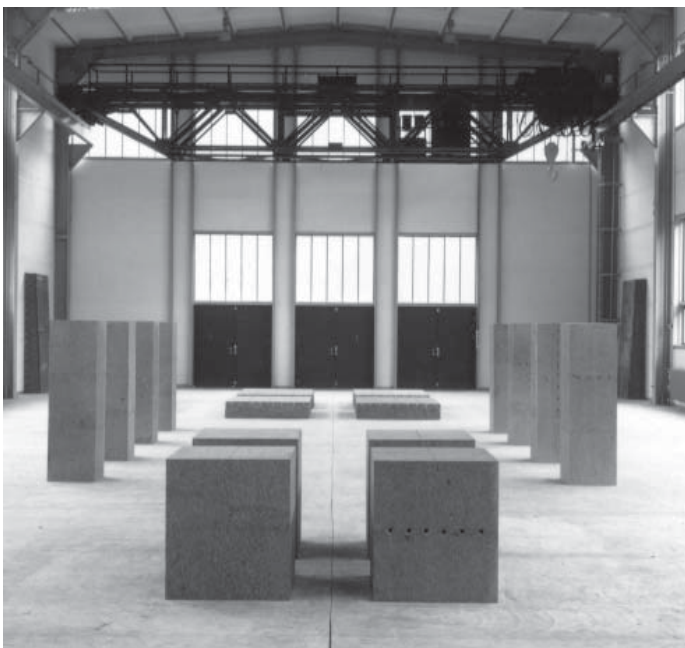
Interior of Hall 5 today.

Similar to the method applied in the central workshop (Hall 5), the electrical workshop underwent only a few changes. The electrical workshop needed to be adapted to the new climatic needs and the fire protection requirements of an exhibition and office space. The outer skin underwent some cleaning and repair work and the curtain wall regained its stability with the introduction of the same auxiliary corset structure from the inside as with Hall 5. Since the new use required better thermal insulation, an existing pumice-concrete inner skin was removed and replaced with a better-insulating plaster wall construction. The use as exhibition and office space also required additional interior partitioning walls. Here again, the existing original structures were updated and only in some cases supplemented

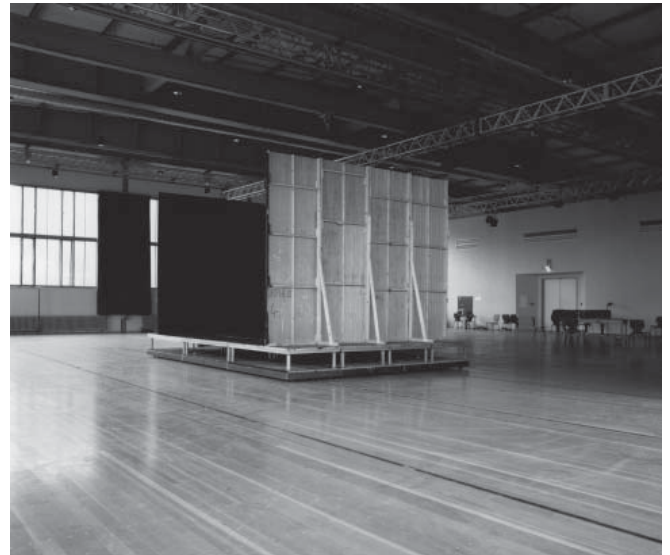
Hall 12 Concert space.

Substantial alterations had to be made to Hall 12. Functioning originally as a bridging structure with tracks on the ground floor, it allowed railway wagons to enter to be loaded with coal from above. To reuse this open ground floor, its front elevation had to be glazed. The horizontal orientation of the new glass panels contrasts with the typical vertical bands of wire glass.

The former railway tracks suggested the idea of preserving public access to the building. Therefore the railway tracks were converted into a sidewalk that leads into the building and functions as a lobby to workshops, offices and a multi-purpose hall on the upper floor. Upstairs, where 900 square meters of space were converted into an assembly room, the historic fixtures of the tipper and sorting machines were preserved and remain visible behind a glass wall, giving testimony of the building's original function.

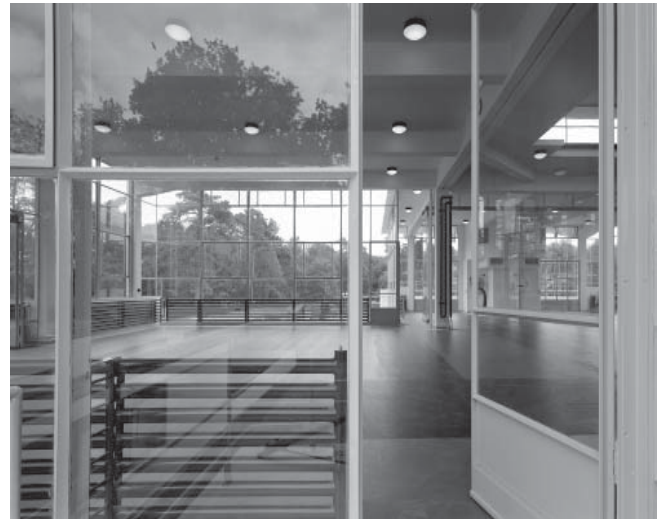
Carefully reconstructed parts such as the steel window casements, the sheet glass and the linoleum floorings.
(Photo: Jannes Linders)

Given the great historic and architectural qualities of the transparent enclosure of the building, it required serious efforts to find types of glass that would be truthful to the perception of the original. Predating the invention of float glass⁷, the drawn sheet glass as used for 'Zonnestraal' was slightly warped, producing vertical distortions, which was essential to the vision and reflection qualities of the state-of-the-art curtain wall of 1928.

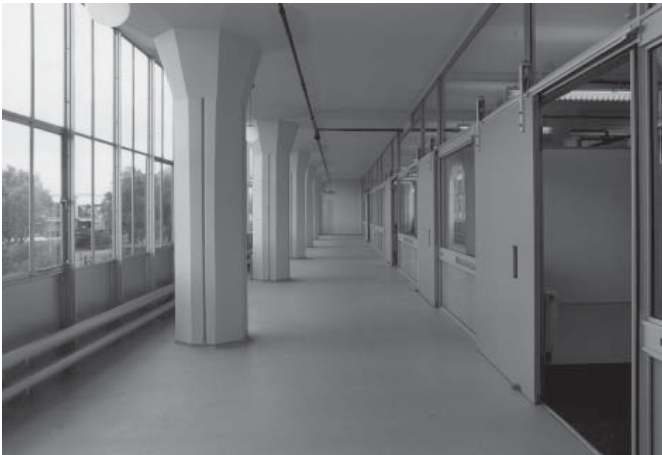
At the shadow-side, the secondary glazing is located at some distance from the original facade leaving enough space for corridors. At the other side, the sun side, the glazing has been placed between the columns, corresponding with the position of the original sunshades, creating a climate-regulating wall. (Photo: Fas Keuzenkamp)

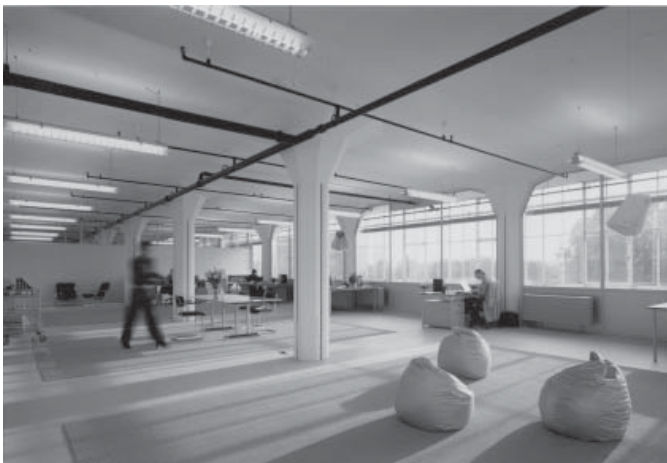
In order to create appropriate workspaces the principle of a double facade was proposed by the project architects. Like in the 1920's, the interiors benefit from daylight and transparency of the buildings. (Photo: Sybolt Voeten)

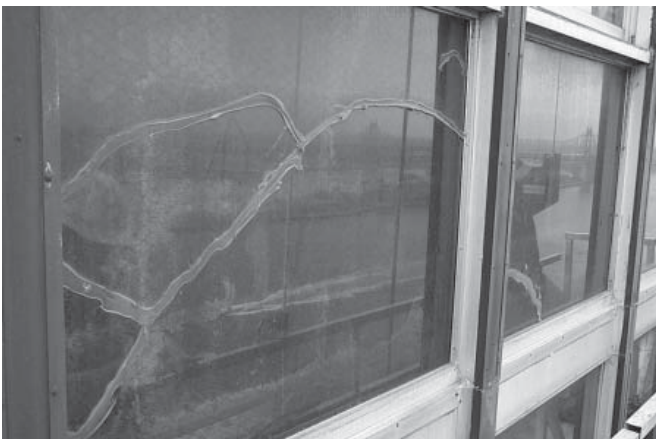
Cracked and sealed spandrel glass.

Caulking and Sealants: Original metal-to-metal seals were made with the asbestos mastic caulking available at the time, a material ill suited to the performance requirements of a skyscraper curtain wall. Subsequent repairs involved a range of successively newer sealants, but the limitations of the original joint design, combined with improper oversealing with incompatible products, precluded the viability of both the original and the replacement seals. Furthermore, because architectural sealants attract and hold dirt, the joints would have appeared shortly after installation to be smeared with grime.

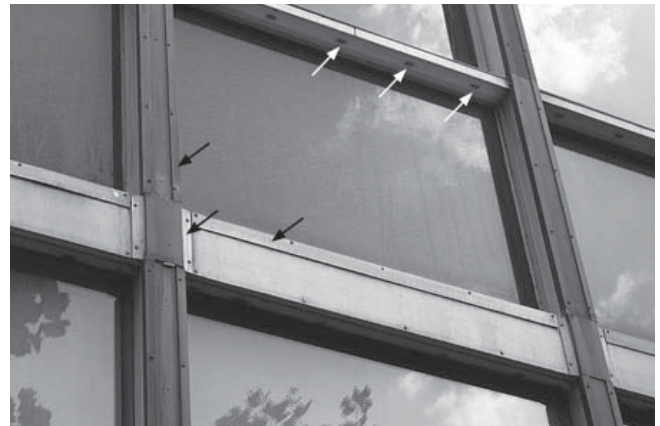
Remedial aluminum covers and weep hole plugs, c. 1952.

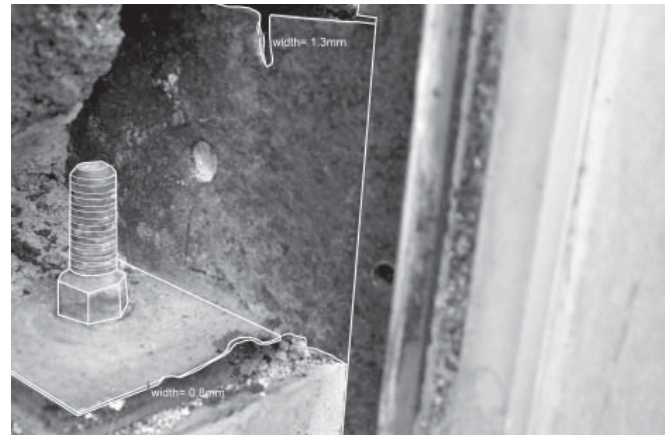
Failed Anchor

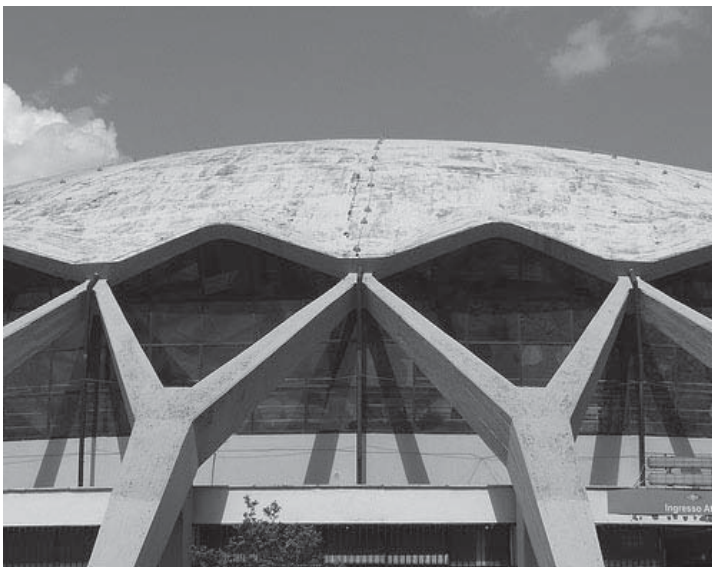
View of Nervi's concrete Y-shaped trestles, Sport Palace, Rome.
(Photo: Sarah Rinehart)

The ground floor of the construction has two levels of tiers. The main structural problem of the construction was the necessity to cover the circular space of almost 100 m in diameter without intermediate pillars. The solution was to put a dome as a covering; however, this involved the question of how to balance the prominent horizontal forces at their impost floor. Given the presence of a very good foundation soil, the most natural and economical solution seemed to be that of bringing, via suitable structures, the actions of the dome directly to the ground. The dome is formed by a wavy structure completed at the upper level by a slab with only 9 cm thickness. The waves are formed by prefabricated elements of the same type of the ones in the Expositions Palace. In this way a system of ribs, connected together by the final slab, is formed by creating a highly resistant structural system. The system achieved is iperstatic. The corrugated dome can be interpreted as a membrane or as a series of

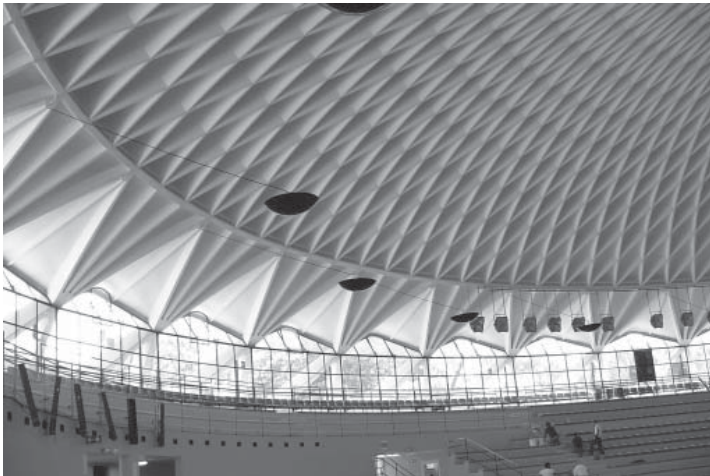
View of interior ribbing. (Photo: Francis Jonckheere)

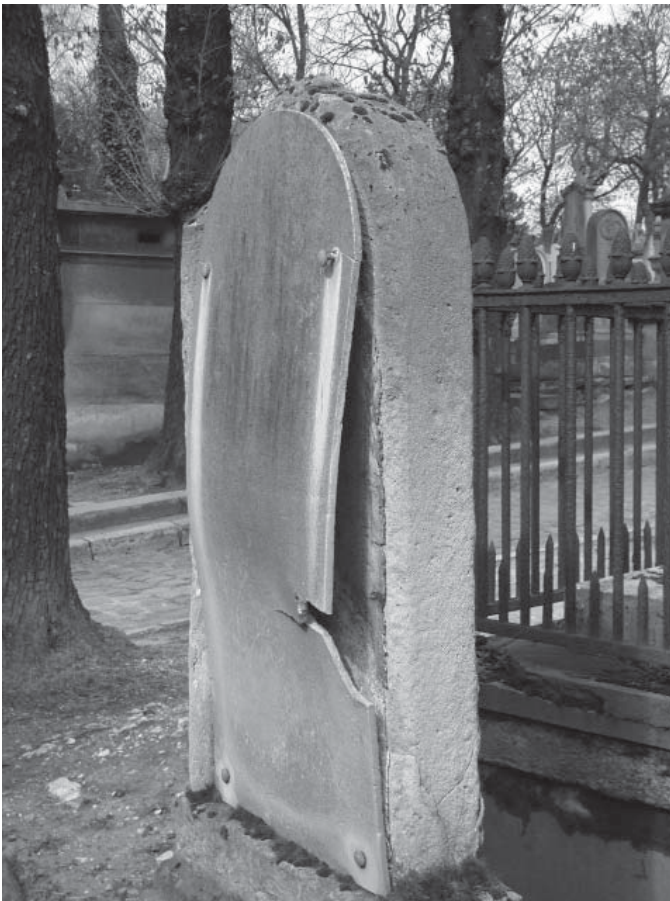
Marble deterioration on a monument in Montmartre cemetery, Paris. (Photo: Brent Gelk)

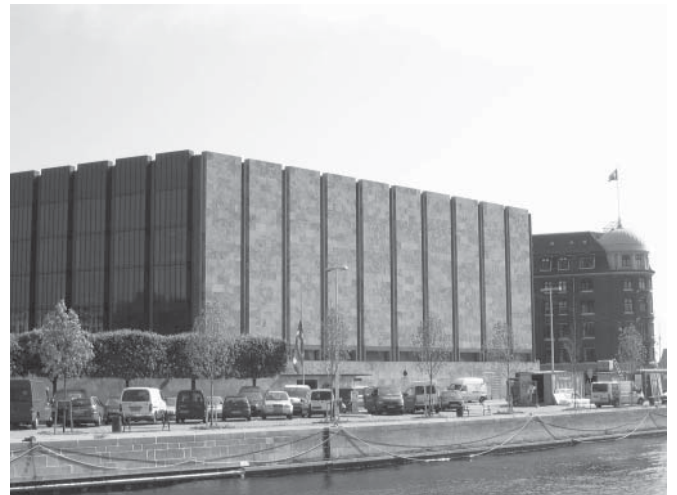
National Bank of Denmark, Copenhagen. (Photo: Brent Gelk)

A wide range of buildings were visited where their condition was recorded along with details of the type of stone used, the panel dimensions, the fixing system, insulation and the local environment. One of the first signs of deformation of marble claddings is usually seen

as bowing. However, the most important physical change observed in marble is the loss of flexural strength, where the recorded strength loss of marble on buildings was between 10 and 85% of its initial strength.⁴ In addition to the bowing and loss of strength, permanent expansions of the marble were also evident. This is often associated with movement of the panels and result in spalling of the stone around the fixing points, and ultimately falling of stones.

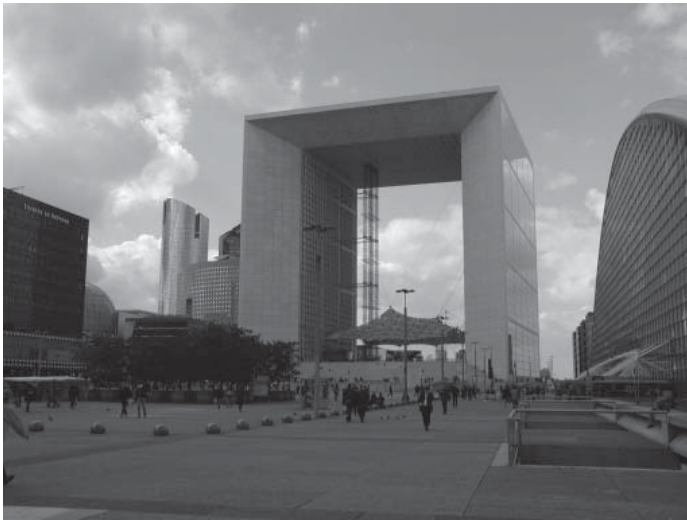
La Grand Arche de La Défense, Paris. (Photo: Brent Gelk)

covered with the white Carrara marble from Italy. After only 15 years of exposure, the panels show high degree of deformation. The most severe panels are bowed 20-30 mm out of their original plane, and a total replacement of the cladding is expected in the foreseeable future.

Serious bowing is observed on La Grand Arche de la Defence in Paris, France from 1989. The building, which was designed by another Danish architect Johan Otto Von Spreckelsen, is

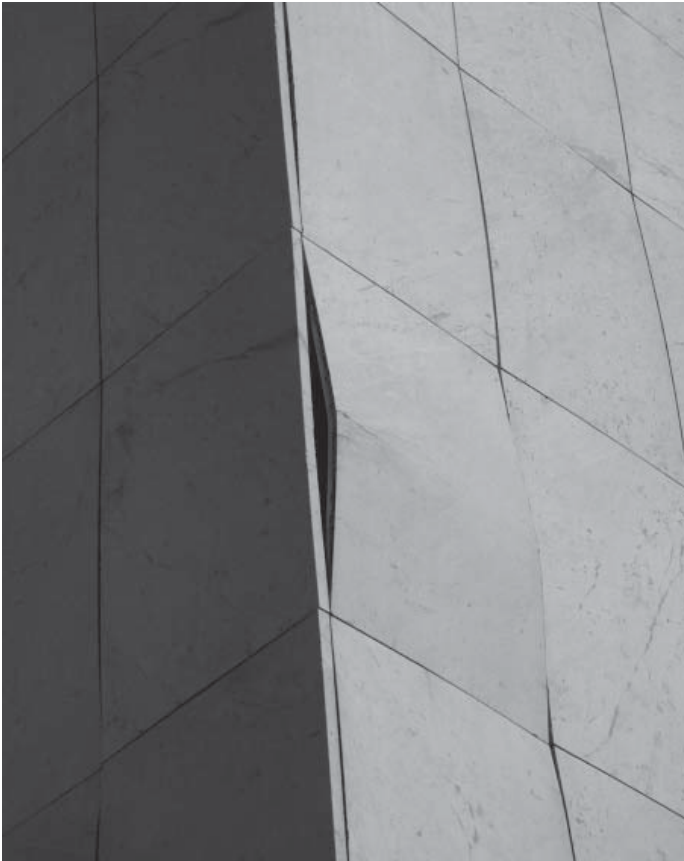
*Detail of deteriorated marble on a hotel, Helsinki.
(Photo: Björn Schouenborg)*

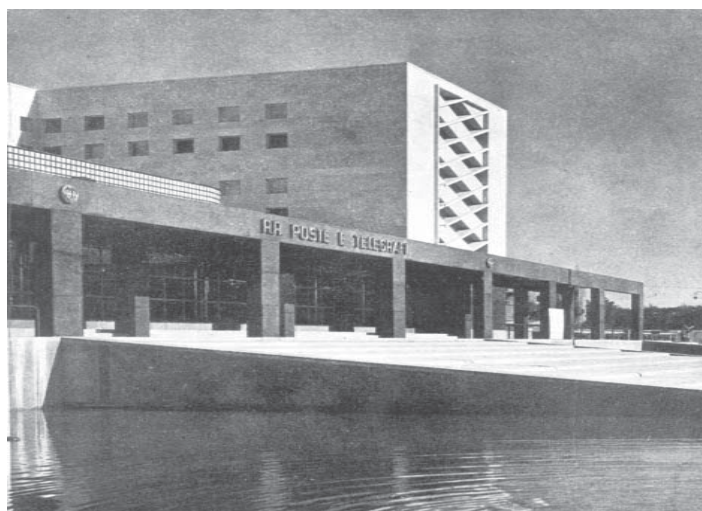
Post Office building on via Marmorata by Adalberto Libera and Mario De Renzi. (Photo: Sergio Poretti, 1990)

Soon after the building was completed, the portico slabs began to detach. The few fixed anchoring points proved insufficient for the large dimension of these slabs (2.15 meters long and 1 meter wide), which were also rather hazardously shaped to reduce the discontinuity in cuts. Diverse thermal dilations between the structure (which had no joints) and the porphyry facing led to stress that could not be absorbed by the metal reinforcing rods.

Finally, in 1997 the Postal Service decided to implement extensive conservation maintenance on the facing. The stone slabs of the main nucleus were consolidated by using stainless steel adhesive anchors, and perforations were sealed with a mixture of putty and travertine powder. An experimental procedure that had been proposed to conceal the adhesive steel anchors — employing the stone wedge that had been removed to insert the adhesive anchors — was not accepted by the building management. Most important, however, violet porphyry was still available, and the portico was returned to its original appearance.

had to be updated. The slabs were to be affixed only to the structure and not joined to each other in order to permit free thermal expansion. This was implemented by adopting a stainless steel framework that joined every individual slab to the pillars and beams with double expansion anchors. In this way, every slab was held in place independently of the others and was slightly distanced from the structure itself.

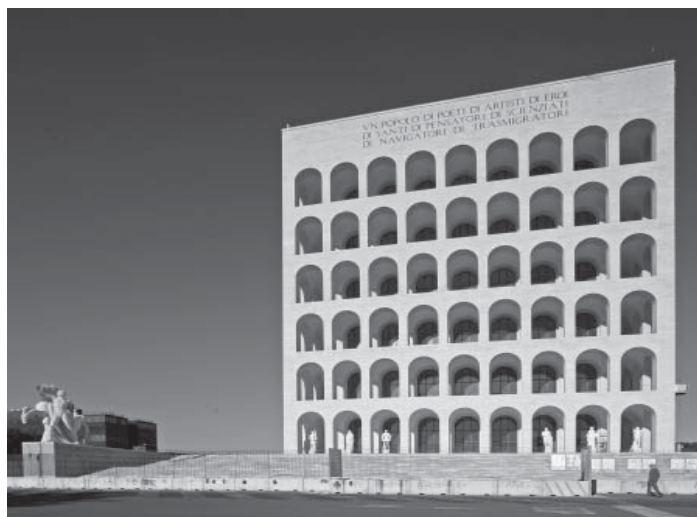
Palazzo della Civiltà Italiana in Rome by Giovanni Guerrini, Ernesto Lapadula, Mario Romano. (Photo: Sergio Poretti)

The complex interactions between the facing and the main supporting structure and the loss in efficiency of the joining cramps have led to the present state of deterioration. This does not, however, present any generalized slab detachment as occurred in the buildings faced with thin slabs. In this case, the deterioration entails local ruptures and loosening of individual elements (mainly the corner slabs due to the load pressure).

materials); integrate the missing slabs (removed years ago to examine the facing and the underlying structure); substitute the newer facing slabs (which usually have a different color and superficial finish); remove all spackle, putty sealing, cramps, and pins added in previous consolidation operations; and spackle and clean the entire surface. In particular, great attention has been paid to perfectly sealing the joints in order to prevent – as far as possible – water leaking behind the facing, which poses the greatest threat to the pins securing the slabs.⁶

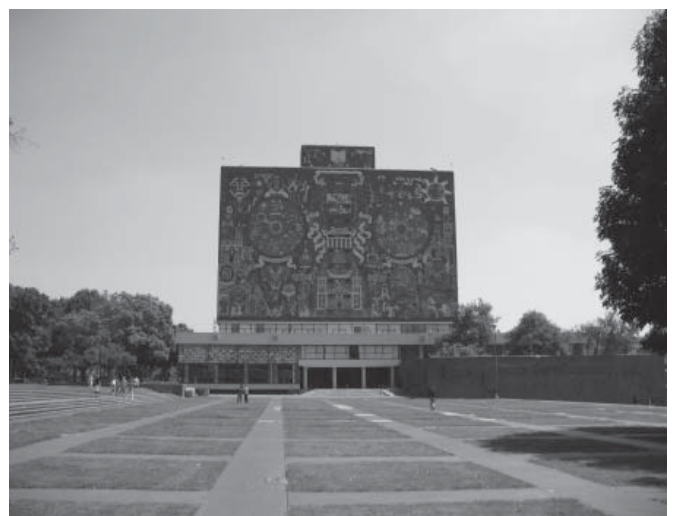
Juan O’Gorman, Gustavo Saavedra and Juan Martinez de Velasco, Murals, Central Library, University City, UNAM, 1952. South Facade. (Photo: Louise Noelle Gras)

1990), environmental conditions (November 1990), petrographic study (June 1991), characterization of glass (July 1991), determination of apparent density and porosity (May 1991), and probable composition of rainwater in Mexico City (June 1992). A precise diagnostic was then elaborated for the restoration project taking first into consideration the construction system employed, as some of the more than 4,000 panels measuring one square meter (3 square feet) each, were exhibiting diverse deformations.

Nevertheless, after 40 years, the decay of the stone mosaics was significant due to, among other factors, problems caused by the construction system and the weathering of the rock materials, as well as significant losses in the surface. Visible damage was triggered by the natural weathering of the diverse types of stone provoked, above all, by the acid rain and the expansion-contraction cycles resulting from temperature variations, as well as the deformation of some of the plaques due to placement and anchoring problems. After a careful

The work consisted of: 1) Air pressure cleaning and washing with natural vegetable detergents (chichi herb); 2) Consolidation, taking into consideration the rainy season periods, humidity, and sunny periods (Wacker OH consolidant); 3) Water-repellent application (Wacker 290 L spray, dissolved in ammonia); 4) Replacement of lost fragments, having located the original quarries used; 5) sealing of the inter-planar joints to avoid water infiltration (with gray urethane sealant that is invisible); and 6) Fastening and adapting the panels with expansion joints for greater movement. Scaffolding was done with swing-stages in order not to touch the walls.

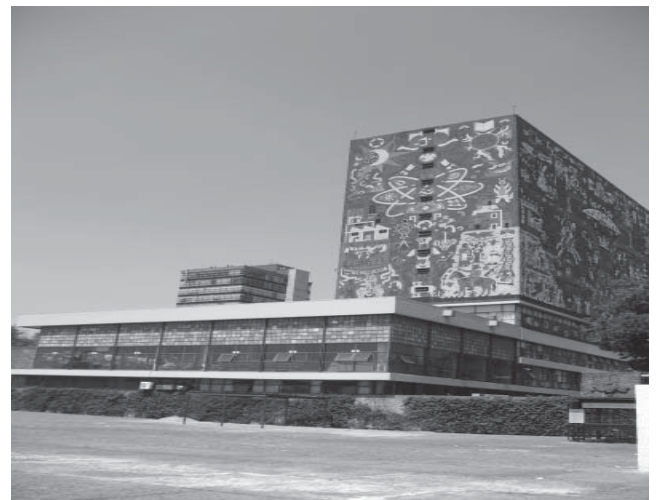
Juan O'Gorman, Gustavo Saavedra and Juan Martínez, *Murals. West facade.* (Photo: Louise Noelle Gras)

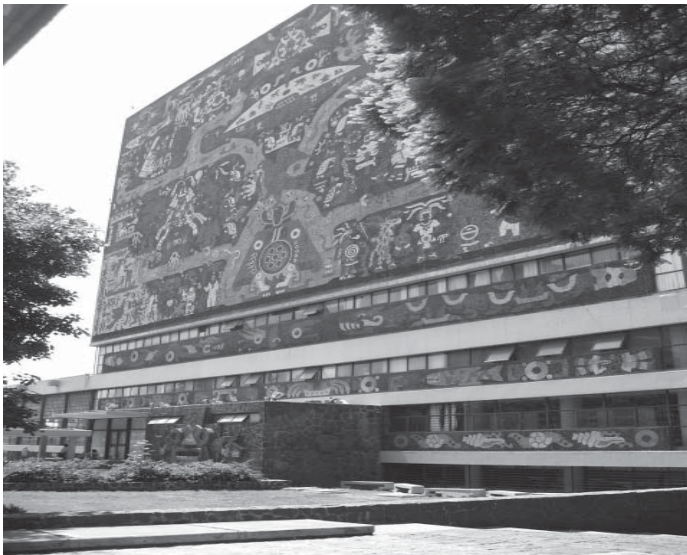
Juan O'Gorman, *Detail of mural, North facade.*
(Photo: Louise Noelle Gras)

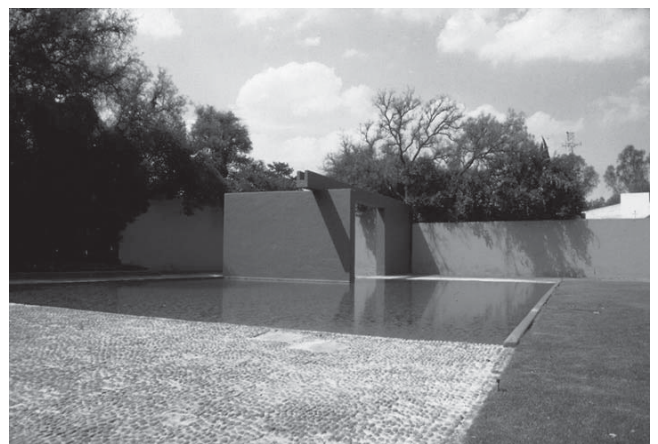
*Luis Barragán, Lovers' Fountain, The Clubs, 1964.
(Photo: Louise Noelle Gras)*

During the restoration of The Lovers' Fountain in 1996, the Residents' Association of Los Clubes made a series of decisions regarding the deteriorated state of the fountain, including the decision to restore the water feeding mechanism; the color and texture chosen, however leave much to be desired. The two wooden troughs, sometimes interpreted as the "lovers," were never replaced and were eventually lost because their perishable material. In the case of El Bebedero, the problem was simpler because a mechanical pump was not needed and there were no wooden elements involved. Also, the white color of the background wall, while an easy victim to graffiti, offered no complications for selecting the new paint color.

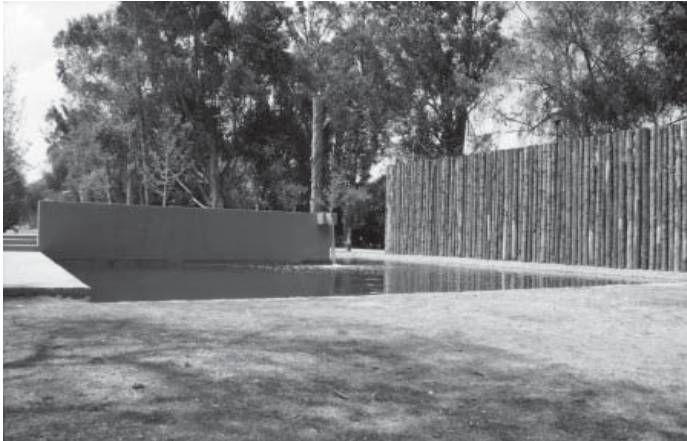
Luis Barragán, Bell Tower Fountain, The Arbors, 1958-61.
(Photo: Louise Noelle Gras)

In the fountain and plaza of El Campanario (the Belltower), which was almost demolished, a more thorough restoration was possible thanks to the generous intervention in 1992 of the Residents' Association of Las Arboledas and the Technological

Institute of Monterrey, Campus State of Mexico, with the support of the Directorate of Architecture and Conservation of Goods and Property of the National Institute of Fine Arts. The site was studied with care, and a series of historic photographs assisted development of a comprehensive reconstruction and restoration plan¹². Challenges included the tree trunks, practically disintegrated after 40 years, and application of the orange paint to the structure. Replacement wood options for the trunks were selected through an analysis of the remains of the originals; the replacement paint color was selected by consensus of original inhabitants from swatches applied to the structure. The final result is favorable, making it possible once again to appreciate this important example of landscape architecture. With it, our descendants will be able to experience the public spaces created by Luis Barragán.
