THE PORTLAND BUILDING

RECONSTRUCTION PROJECT

DESIGN ADVICE REQUEST

December 19, 2016

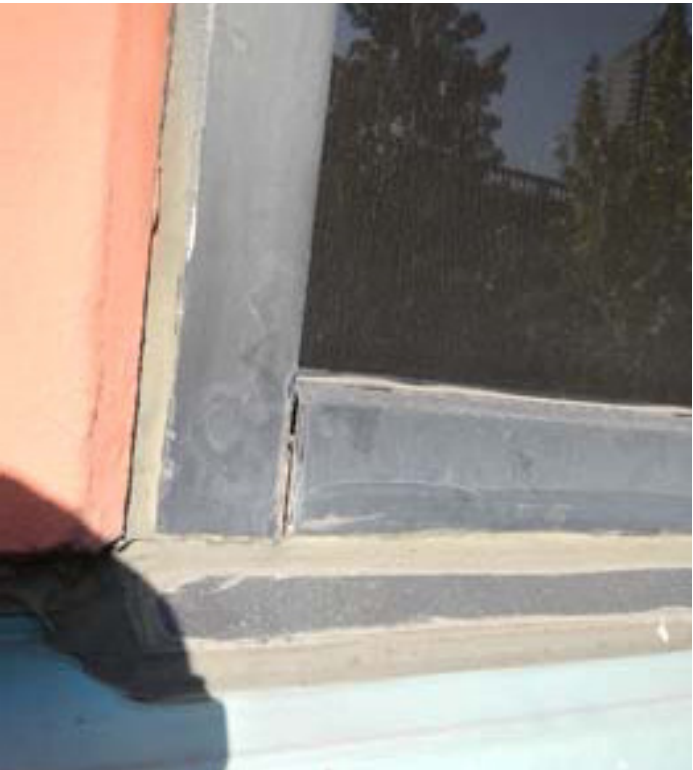
Sealant applied over curtainwall drainage outlet

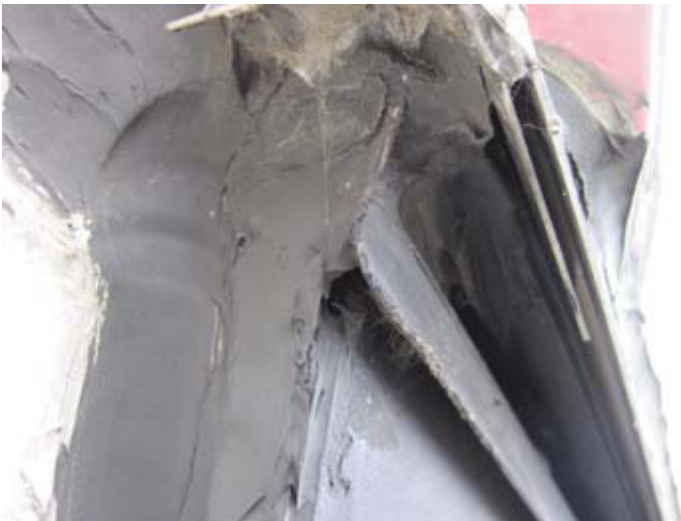
Multiple layers of sealant applications

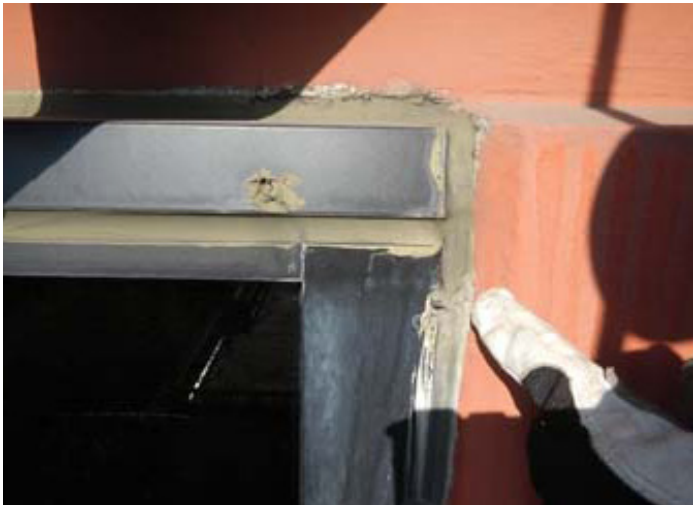
Sealant applied under head flashing

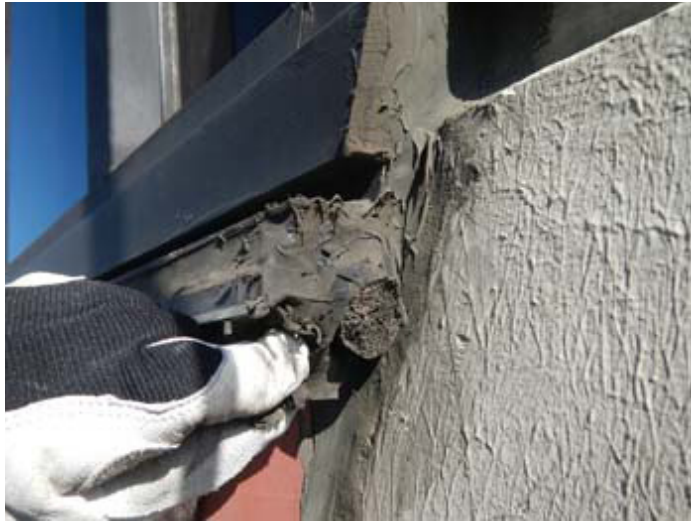
Multiple layers of sealant applications

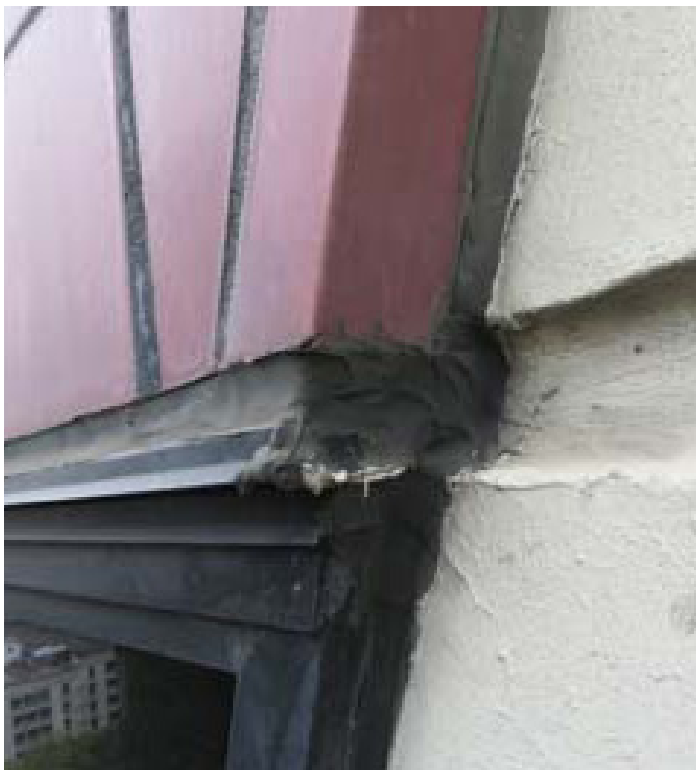
Ribbon window head below reveal

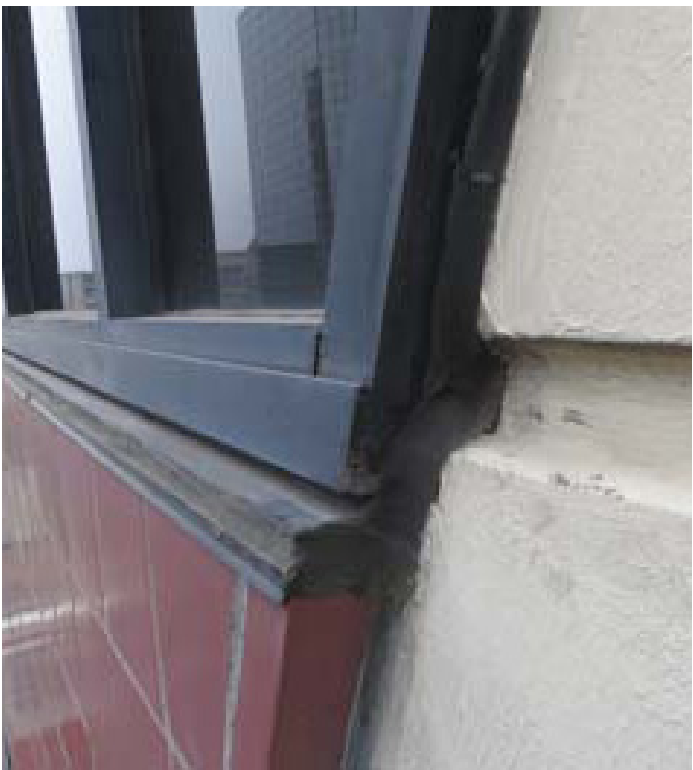
Ribbon window sill aligned with reveal

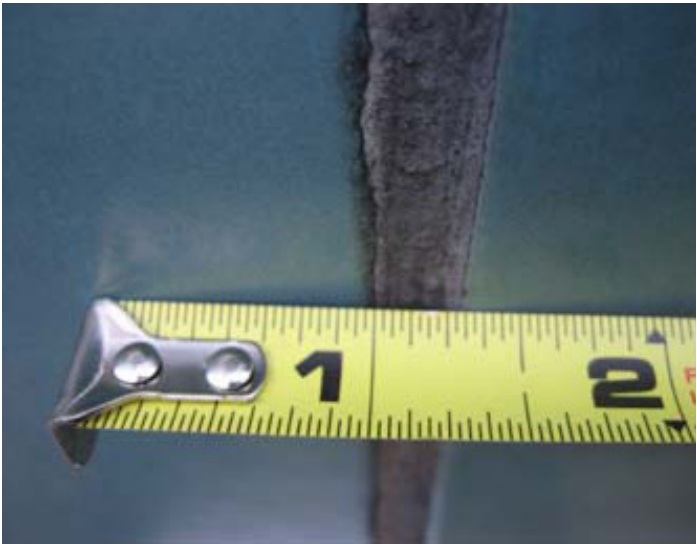
- Irregular grout joint size - The existing grout joints vary from less than 1/2" to over 1" in width. Wide grout joints are more susceptible to shrinking and cracking.
- Tiles cut for size/shape - Tiles were frequently cut down in areas where openings or other features were intended to align with the tile module. While there are some tiles that were fabricated for specialty conditions like corners, there are many instances where field tiles were cut instead. This resulted in conditions where tile bisque is exposed to the elements and/or grout joints are irregular in width.
- Alignment - There appears to be a design intent to align window systems with the reveal pattern, however this alignment is irregular with some elements occurring at the reveal and others below the reveal. These conditions exist at most curtainwall/ribbon window locations.

Irregular grout joint size
